# **Full Reserve Study For Pine Ridge Plantation CDD Middleburg, Florida**

**For Period: October 1, 2014 to September 30, 2015**

**Report Date: November 12, 2014**

**Revision II**

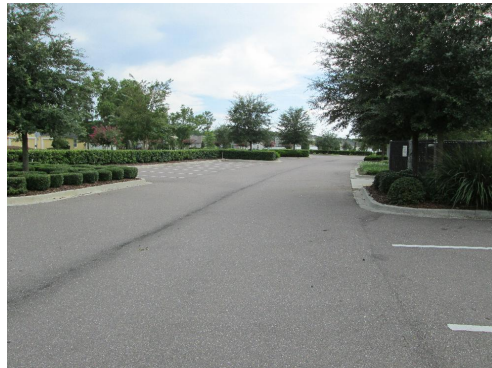
## **Asphalt Resurfacing - 2032**

2,400 Square Yards	@ \$13.00
		Asset Cost	\$31,200.00
		Percent Replacement	100%
		Future Cost	\$53,115.91
	Site Components		
Placed in Service	June 2008		
Useful Life	25		
Replacement Year	32-33		
Remaining Life	18

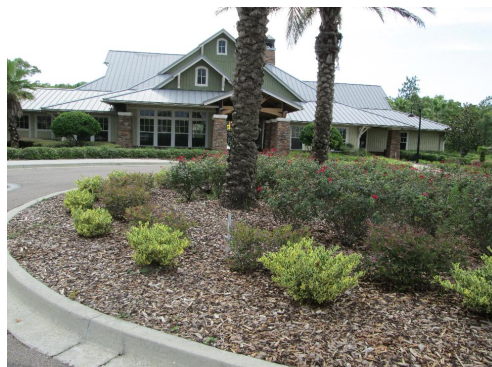
## **Concrete Curbing - 2032**

1,600 Linear Feet	@ \$11.00
		Asset Cost	\$4,400.00
		Percent Replacement	25%
		Future Cost	\$7,490.70
	Site Components		
Placed in Service	June 2008		
Useful Life	25		
Replacement Year	32-33		
Remaining Life	18

Replacement allowance of 25% at time of resurfacing.

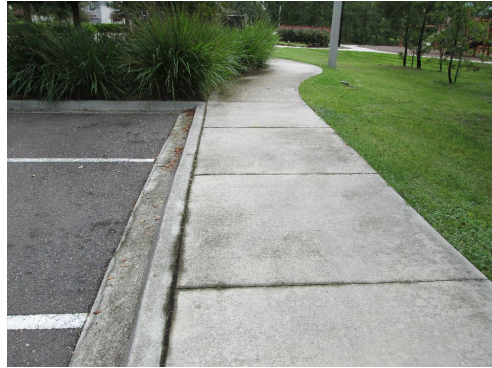
808 Square Yards	@ \$40.00
		Asset Cost	\$4,848.00
		Percent Replacement	15%
		Future Cost	\$8,253.39
	Site Components		
Placed in Service	June 2008		
Useful Life	25		
Replacement Year	32-33		
Remaining Life	18

15% replacement due to damage from vehicles or tree roots.

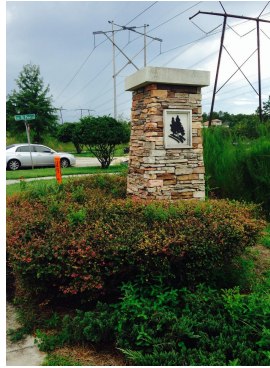
**Monument Sign B Refurbishment - 2032**

1 Lump Sum	@ \$1,200.00
		Asset Cost	\$1,200.00
		Percent Replacement	100%
		Future Cost	\$2,042.92
	Site Components		
Placed in Service	June 2008		
Useful Life	25		
Replacement Year	32-33		
Remaining Life	18

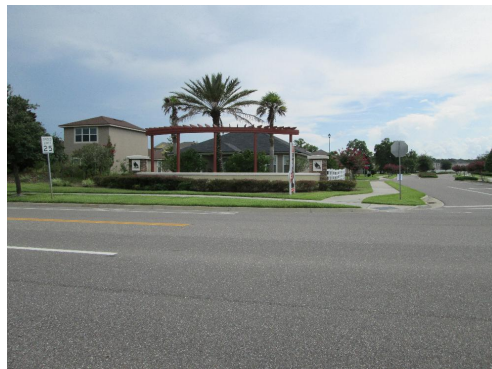
**Wood Pergola A - 2027**

160 Square Feet	@ \$18.00
		Asset Cost	\$2,880.00
		Percent Replacement	100%
		Future Cost	\$4,229.38
	Site Components		
Placed in Service	June 2008		
Useful Life	20		
Replacement Year	27-28		
Remaining Life	13

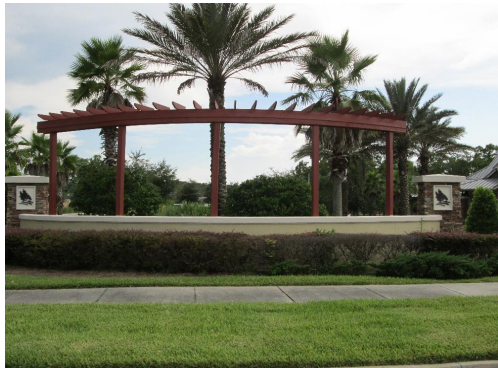
**Wood Pergola B - 2027**

160 Square Feet	@ \$18.00
		Asset Cost	\$2,880.00
		Percent Replacement	100%
		Future Cost	\$4,229.38
	Site Components		
Placed in Service	June 2008		
Useful Life	20		
Replacement Year	27-28		
Remaining Life	13

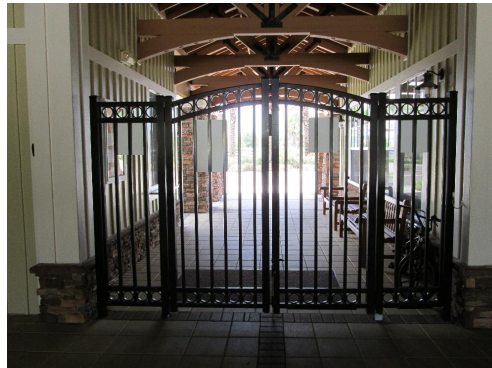
**Aluminium Entry Gates - 2021**

2 Each	@ \$1,600.00
		Asset Cost	\$3,200.00
		Percent Replacement	100%
		Future Cost	\$3,935.60
Placed in Service	Fencing		
	June 2008		
Useful Life	14		
Replacement Year	21-22		
Remaining Life	7

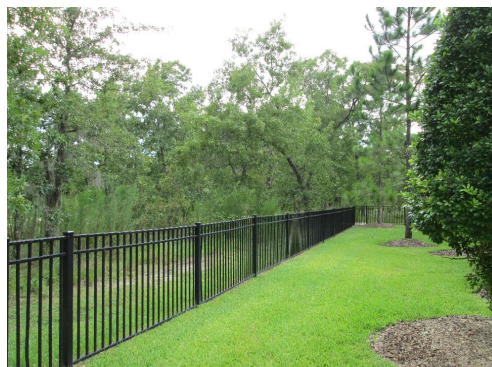
**Aluminium Fencing - 2037**

652 Linear Feet	@ \$31.00
		Asset Cost	\$20,212.00
		Percent Replacement	100%
		Future Cost	\$39,890.13
Placed in Service	Fencing		
	June 2008		
Useful Life	30		
Replacement Year	37-38		
Remaining Life	23

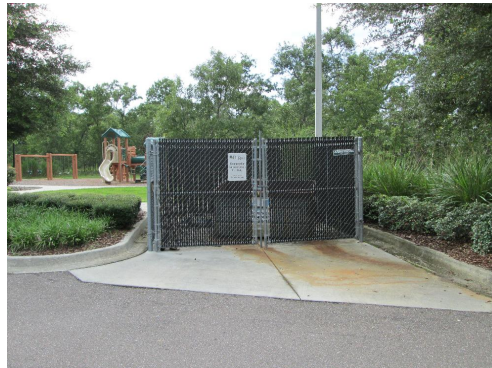
## Dumpster Fencing & Gates - 2025

48 Linear Feet	@ \$26.00
		Asset Cost	\$1,248.00
		Percent Replacement	100%
		Future Cost	\$1,727.52
Placed in Service	Fencing		
Useful Life	June 2008		
Replacement Year	18		
Remaining Life	25-26		
	11

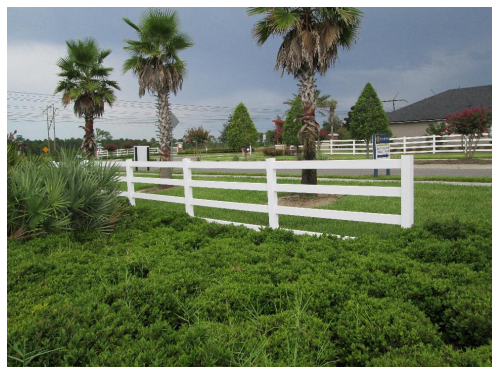
## Vinyl Fencing - 2037

82 Linear Feet	@ \$26.00
		Asset Cost	\$2,132.00
		Percent Replacement	100%
		Future Cost	\$4,207.68
Placed in Service	Fencing		
Useful Life	June 2008		
Replacement Year	30		
Remaining Life	37-38		
	23

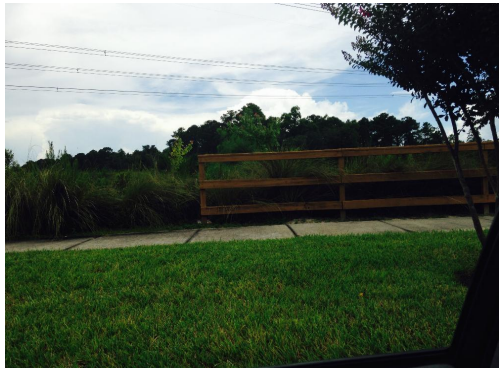
Wood Fence - 2029

304 Linear Feet	@ \$15.00
		Asset Cost	\$4,560.00
		Percent Replacement	100%
		Future Cost	\$7,104.33
Placed in Service	Fencing		
Useful Life	June 2008		
Replacement Year	22		
Remaining Life	29-30		
	15

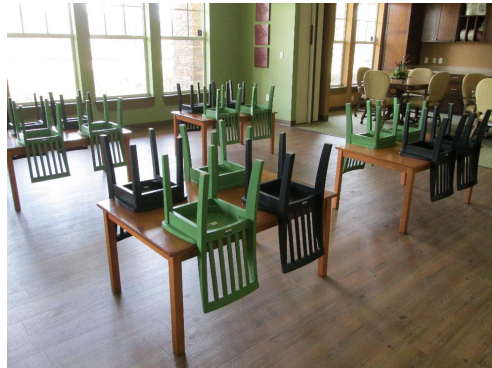
**Folding Partition - Meeting Room - 2035**

13 Linear Feet	@ \$200.00
		Asset Cost	\$2,600.00
		Percent Replacement	100%
		Future Cost	\$4,836.76
<b>Building Components</b>			
Placed in Service	June 2008		
Useful Life	28		
Replacement Year	35-36		
Remaining Life	21

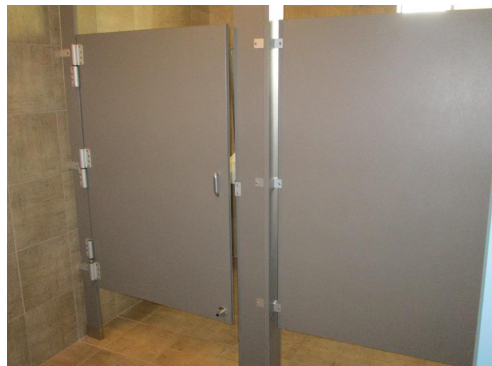
**Toilet Partitions - Clubhouse Mens Room - 2032**

1 Stalls	@ \$2,000.00
		Asset Cost	\$2,000.00
		Percent Replacement	100%
		Future Cost	\$3,404.87
<b>Building Components</b>			
Placed in Service	June 2008		
Useful Life	25		
Replacement Year	32-33		
Remaining Life	18

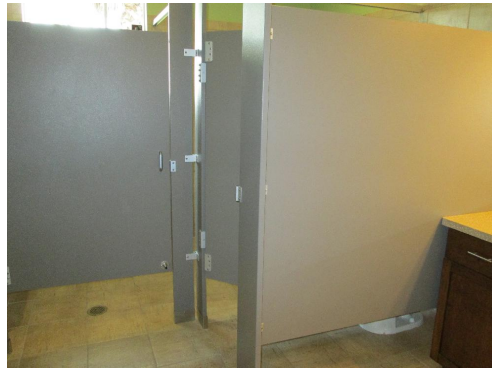
**Toilet Partitions - Clubhouse Womens Room - 2032**

2 Stalls	@ \$2,000.00
		Asset Cost	\$4,000.00
		Percent Replacement	100%
		Future Cost	\$6,809.73
	Building Components		
Placed in Service	June 2008		
Useful Life	25		
Replacement Year	32-33		
Remaining Life	18

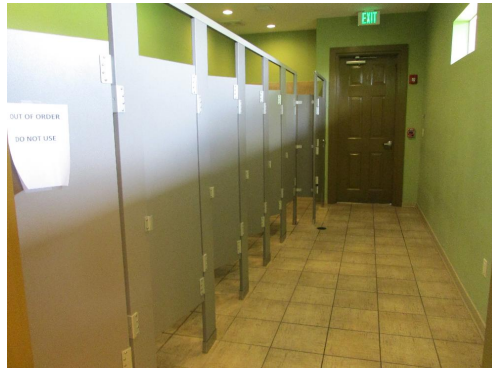
**Toilet Partitions - Womens Locker Room - 2032**

7 Stalls	@ \$2,000.00
		Asset Cost	\$14,000.00
		Percent Replacement	100%
		Future Cost	\$23,834.06
	Building Components		
Placed in Service	June 2008		
Useful Life	25		
Replacement Year	32-33		
Remaining Life	18

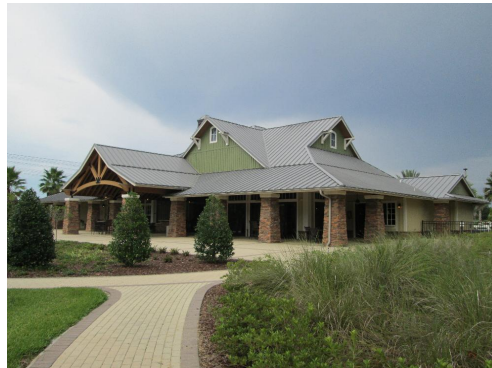
**Metal Roof - Clubhouse - 2037**

12,200 Square Feet	@ \$12.50
		Asset Cost	\$152,500.00
		Percent Replacement	100%
		Future Cost	\$300,971.94
Placed in Service	Roofing		
Useful Life	June 2008		
Replacement Year	30		
Remaining Life	37-38		
	23

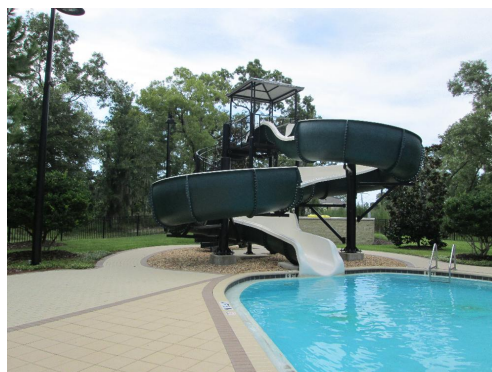
**Metal Roof - Pool Slide Tower - 2037**

80 Square Feet	@ \$12.50
		Asset Cost	\$1,000.00
		Percent Replacement	100%
		Future Cost	\$1,973.59
Placed in Service	Roofing		
Useful Life	June 2008		
Replacement Year	30		
Remaining Life	37-38		
	23

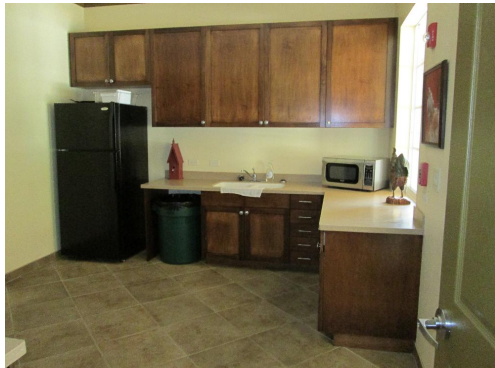
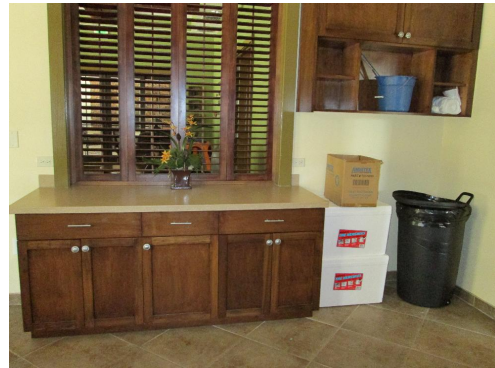
**Base Cabinets & Tops - Serving Room - 2027**

29 Linear Feet	@ \$150.00
		Asset Cost	\$4,350.00
		Percent Replacement	100%
		Future Cost	\$6,388.12
	Cabinets & Tops		
Placed in Service	June 2008		
Useful Life	20		
Replacement Year	27-28		
Remaining Life	13

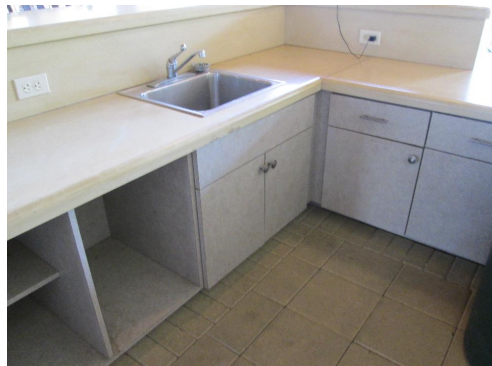
**Cabinets & Top - Outdoor Gathering - 2025**

15 Linear Feet	@ \$200.00
		Asset Cost	\$3,000.00
		Percent Replacement	100%
		Future Cost	\$4,152.70
	Cabinets & Tops		
Placed in Service	June 2008		
Useful Life	18		
Replacement Year	25-26		
Remaining Life	11

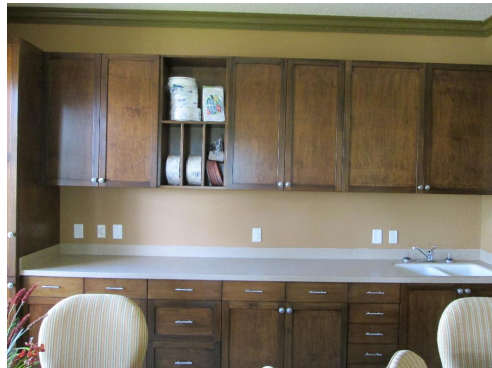
**Cabinets & Tops - Meeting Area - 2027**

14 Linear Feet	@ \$250.00
		Asset Cost	\$3,500.00
		Percent Replacement	100%
		Future Cost	\$5,139.87
	Cabinets & Tops		
Placed in Service	June 2008		
Useful Life	20		
Replacement Year	27-28		
Remaining Life	13

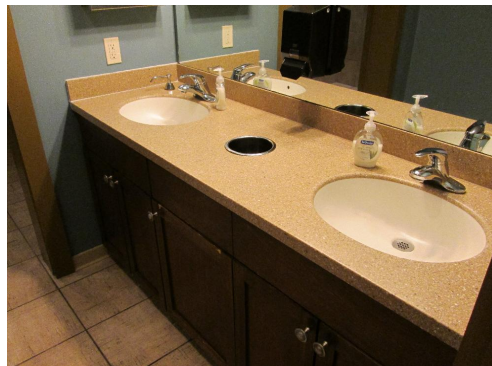
**Cabinets & Tops - Mens Locker Room - 2022**

8 Linear Feet	@ \$200.00
		Asset Cost	\$1,600.00
		Percent Replacement	100%
		Future Cost	\$2,026.83
	Cabinets & Tops		
Placed in Service	June 2008		
Useful Life	15		
Replacement Year	22-23		
Remaining Life	8

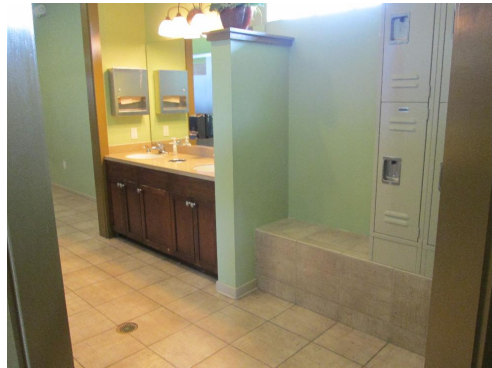
**Cabinets & Tops - Womens Locker Room - 2022**

8 Linear Feet	@ \$200.00
		Asset Cost	\$1,600.00
		Percent Replacement	100%
		Future Cost	\$2,026.83
Placed in Service	Cabinets & Tops		
Useful Life	June 2008		
Replacement Year	15		
Remaining Life	22-23		
	8

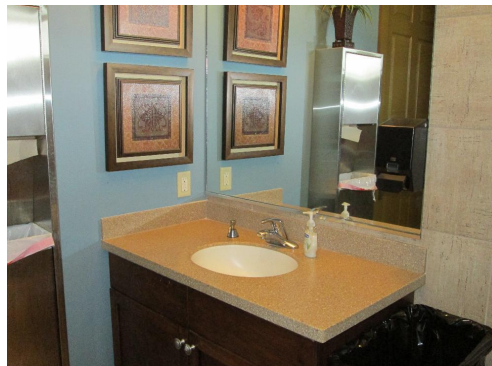
**Vanity & Top - Clubhouse Mens Room - 2022**

1 Each	@ \$1,800.00
		Asset Cost	\$1,800.00
		Percent Replacement	100%
		Future Cost	\$2,280.19
Placed in Service	Cabinets & Tops		
Useful Life	June 2008		
Replacement Year	15		
Remaining Life	22-23		
	8

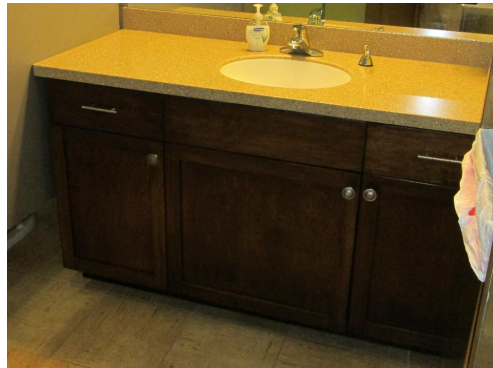
**Vanity & Top - Clubhouse Womens Room - 2022**

1 Each	@ \$2,200.00
		Asset Cost	\$2,200.00
		Percent Replacement	100%
		Future Cost	\$2,786.89
	Cabinets & Tops		
Placed in Service	June 2008		
Useful Life	15		
Replacement Year	22-23		
Remaining Life	8

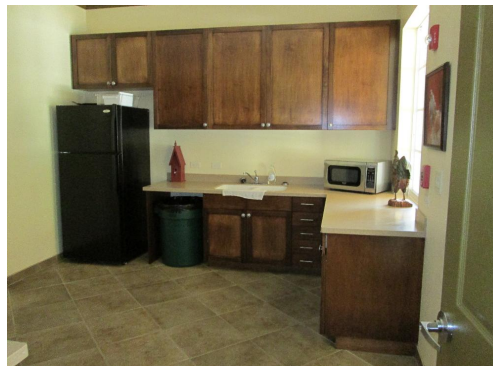
**Wall Cabinets - Serving Room - 2027**

12 Linear Feet	@ \$100.00
		Asset Cost	\$1,200.00
		Percent Replacement	100%
		Future Cost	\$1,762.24
	Cabinets & Tops		
Placed in Service	June 2008		
Useful Life	20		
Replacement Year	27-28		
Remaining Life	13

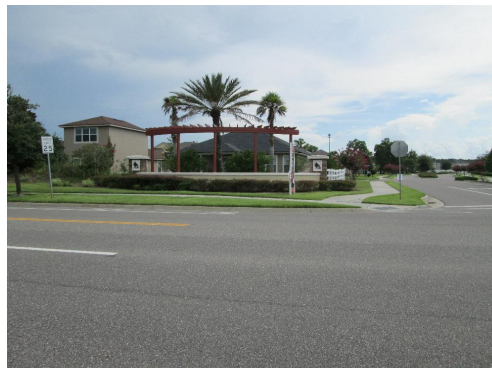
**Painting - Entry Feature Wall A - 2019**

700 Square Feet	@ \$2.40
		Asset Cost	\$1,680.00
		Percent Replacement	100%
		Future Cost	\$1,947.58
Placed in Service	Painting		
Useful Life	June 2008		
Replacement Year	12		
Remaining Life	19-20		
	5

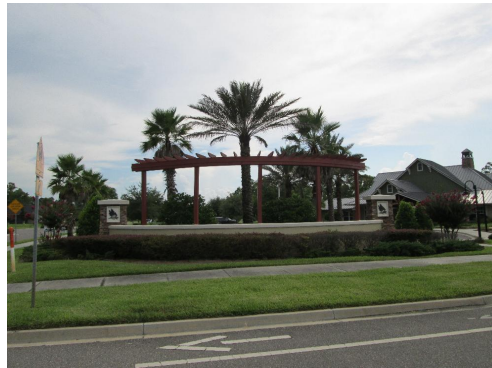
**Painting - Entry Feature Wall B - 2019**

700 Square Feet	@ \$2.40
		Asset Cost	\$1,680.00
		Percent Replacement	100%
		Future Cost	\$1,947.58
Placed in Service	Painting		
	June 2008		
Useful Life	12		
Replacement Year	19-20		
Remaining Life	5

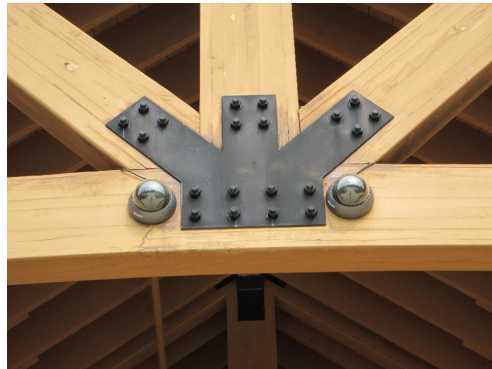
2,600 Square Feet	@ \$2.40
		Asset Cost	\$6,240.00
		Percent Replacement	100%
		Future Cost	\$7,233.87
Placed in Service	Painting		
	June 2008		
Useful Life	10		
Adjustment	2		
Replacement Year	19-20		
Remaining Life	5

Exposed truss ends require immediate caulking and painting. See photo with camera location.

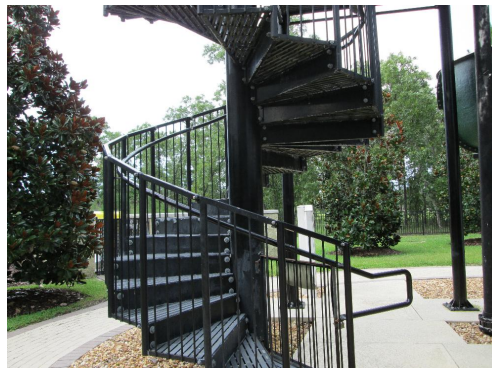
## **Painting - Pool Slide Stairs - 2014**

1 Lump Sum	@ \$3,000.00
		Asset Cost	\$3,000.00
		Percent Replacement	100%
		Future Cost	\$3,000.00
Placed in Service	Painting		
Useful Life	June 2008		
Adjustment	8		
Replacement Year	-1		
Remaining Life	14-15		
	0

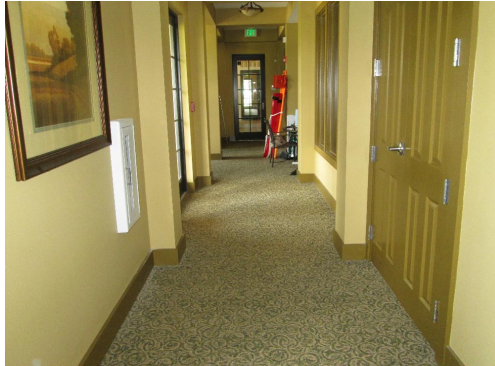
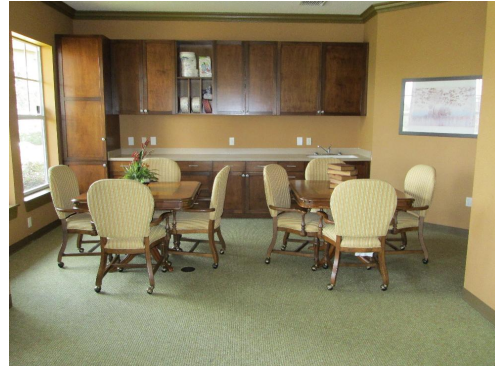
**Carpet - Clubhouse - 2019**

128 Square Yards	@ \$36.00
		Asset Cost	\$4,608.00
		Percent Replacement	100%
		Future Cost	\$5,341.93
Placed in Service	Flooring		
Useful Life	June 2008		
Adjustment	8		
Replacement Year	4		
Remaining Life	19-20		
	5

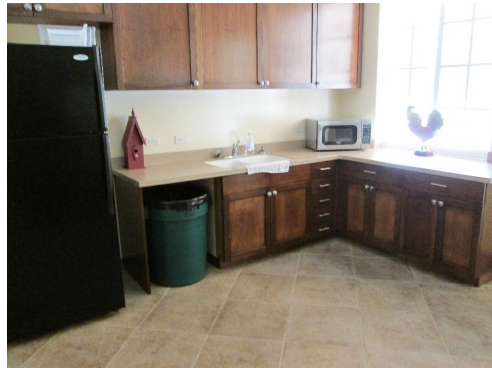
**Tile Floor - Serving Room - 2027**

260 Square Feet	@ \$12.75
		Asset Cost	\$3,315.00
		Percent Replacement	100%
		Future Cost	\$4,868.19
Placed in Service	Flooring		
	June 2008		
Useful Life	20		
Replacement Year	27-28		
Remaining Life	13

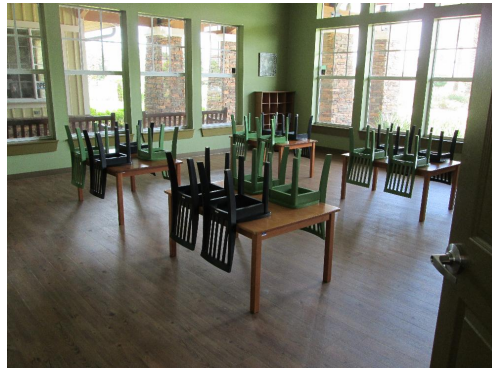
**Vinyl Plank Floor - Children's Activity Room - 2032**

456 Square Feet	@ \$8.00
		Asset Cost	\$3,648.00
		Percent Replacement	100%
		Future Cost	\$6,210.47
Placed in Service	Flooring		
	June 2008		
Useful Life	25		
Replacement Year	32-33		
Remaining Life	18

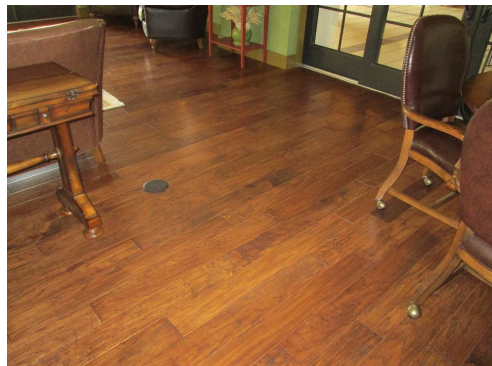
**Wood Floor - Family Gathering Room - 2037**

840 Square Feet	@ \$9.85
		Asset Cost	\$8,274.00
		Percent Replacement	100%
		Future Cost	\$16,329.45
Placed in Service	Flooring		
	June 2008		
Useful Life	30		
Replacement Year	37-38		
Remaining Life	23

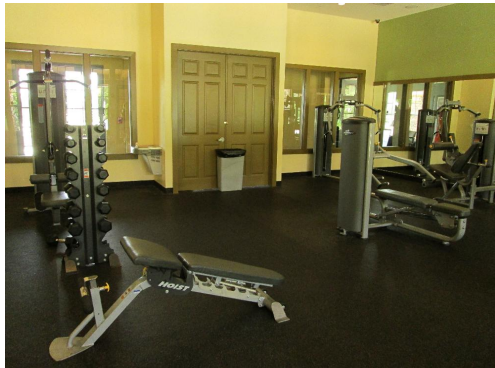
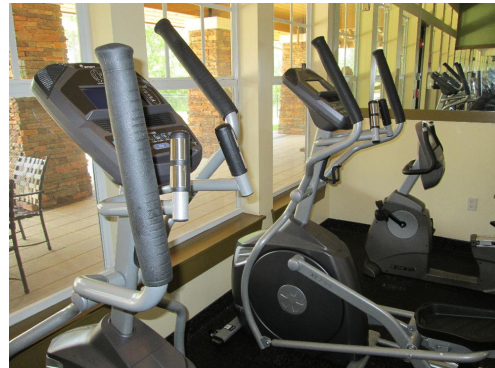
**Fitness Equipment Replacement Allowance - 2014**

Furniture Fixtures & Equipment		1 Lump Sum	@ \$2,500.00
Placed in Service		Asset Cost	\$2,500.00
Useful Life		Percent Replacement	100%
Replacement Year		Future Cost	\$2,500.00
Remaining Life			
	June 2008		
	1		
	14-15		
	0

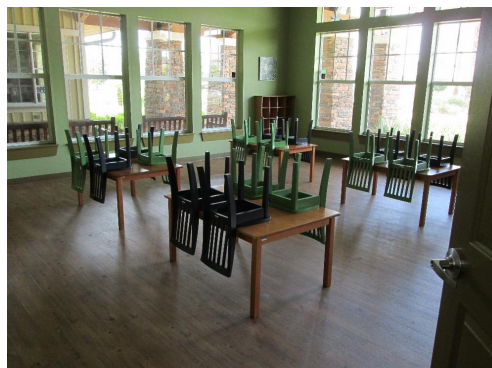
**Furniture - Children's Activity Room - 2023**

Furniture Fixtures & Equipment		1 Lump Sum	@ \$4,000.00
Placed in Service		Asset Cost	\$4,000.00
Useful Life		Percent Replacement	100%
Adjustment		Future Cost	\$5,219.09
Replacement Year			
Remaining Life			
	June 2008		
	12		
	4		
	23-24		
	9

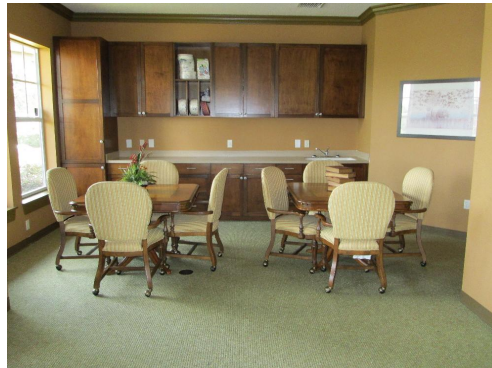
**Furniture - Meeting Area - 2021**

Furniture Fixtures & Equipment		1 Lump Sum	@ \$2,500.00
Placed in Service		Asset Cost	\$2,500.00
Useful Life		Percent Replacement	100%
Replacement Year		Future Cost	\$3,074.68
Remaining Life

June 2008  
14  
21-22  
7

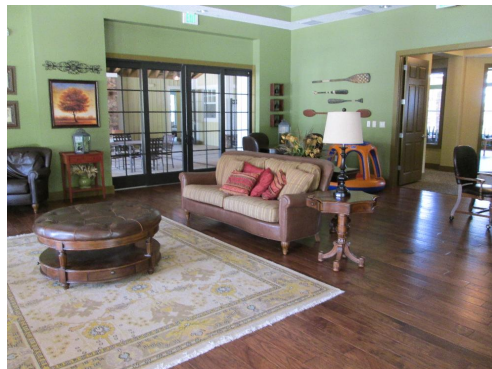
**Furniture Replacement - Family Gathering Room - 2021**

Furniture Fixtures & Equipment		1 Lump Sum	@ \$3,500.00
Placed in Service		Asset Cost	\$3,500.00
Useful Life		Percent Replacement	100%
Replacement Year		Future Cost	\$4,304.56
Remaining Life

June 2008  
14  
21-22  
7

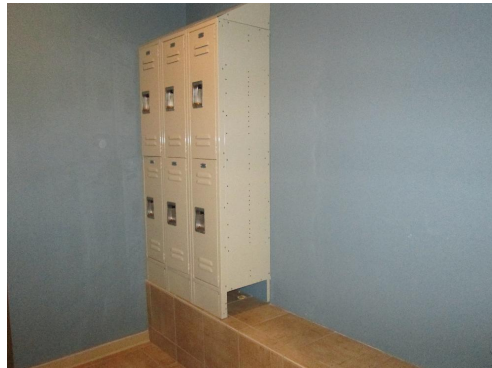
**Metal Lockers - Mens Locker Room - 2027**

6 Each	@ \$50.00
		Asset Cost	\$300.00
		Percent Replacement	100%
		Future Cost	\$440.56
Furniture Fixtures & Equipment			
Placed in Service	June 2008		
Useful Life	20		
Replacement Year	27-28		
Remaining Life	13

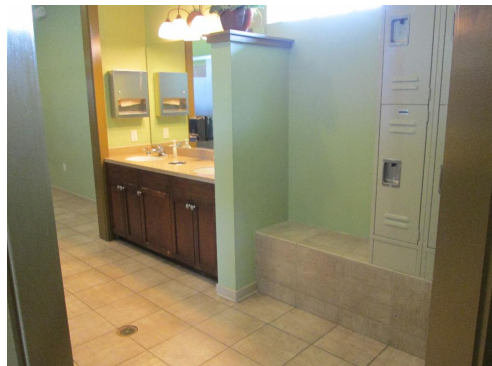
**Metal Lockers - Womens Locker Room - 2027**

6 Square Feet	@ \$50.00
		Asset Cost	\$300.00
		Percent Replacement	100%
		Future Cost	\$440.56
Furniture Fixtures & Equipment			
Placed in Service	June 2008		
Useful Life	20		
Replacement Year	27-28		
Remaining Life	13

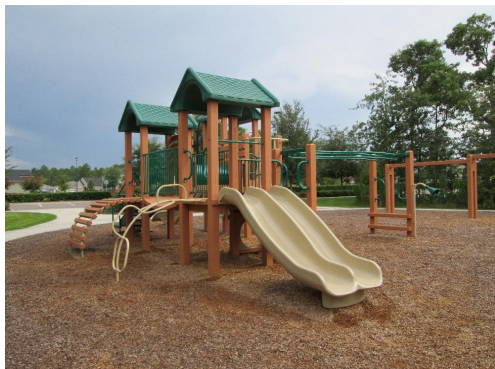
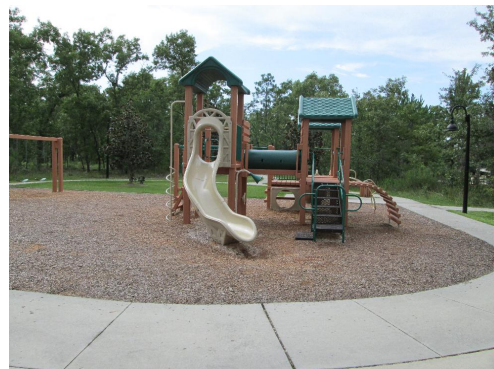
### Playground Equipment Replacement Allowance - 2027

1 Lump Sum	@ \$18,000.00
		Asset Cost	\$18,000.00
		Percent Replacement	100%
		Future Cost	\$26,433.61
Furniture Fixtures & Equipment			
Placed in Service	June 2013		
Useful Life	15		
Replacement Year	27-28		
Remaining Life	13

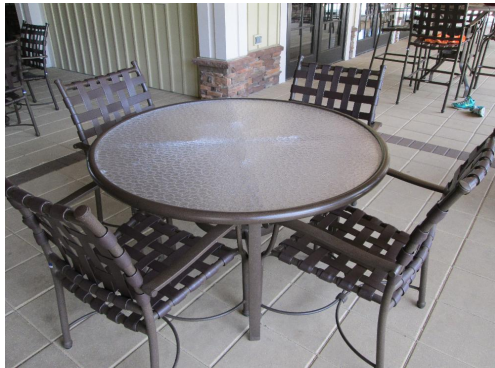
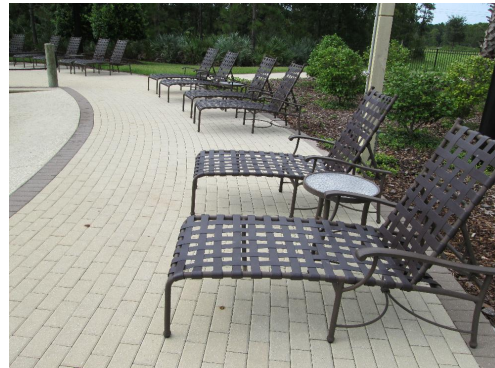
**Pool & Patio Furniture Replacement Allowance - 2014**

1 Lump Sum	@ \$2,000.00
		Asset Cost	\$2,000.00
		Percent Replacement	100%
		Future Cost	\$2,000.00
Furniture Fixtures & Equipment			
Placed in Service	June 2008		
Useful Life	1		
Replacement Year	14-15		
Remaining Life	0

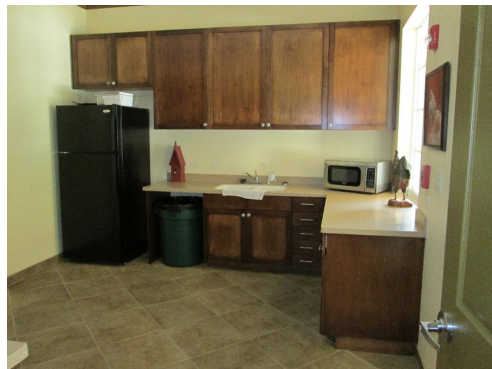
**Refrigerator - 2019**

1 Each	@ \$1,200.00
		Asset Cost	\$1,200.00
		Percent Replacement	100%
		Future Cost	\$1,391.13
Furniture Fixtures & Equipment			
Placed in Service	June 2008		
Useful Life	12		
Replacement Year	19-20		
Remaining Life	5

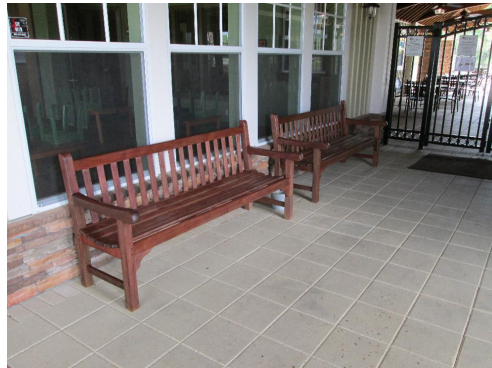
**Wood Benches - 2022**

2 Each	@ \$1,000.00
		Asset Cost	\$2,000.00
		Percent Replacement	100%
		Future Cost	\$2,533.54
Furniture Fixtures & Equipment			
Placed in Service	June 2008		
Useful Life	12		
Adjustment	3		
Replacement Year	22-23		
Remaining Life	8

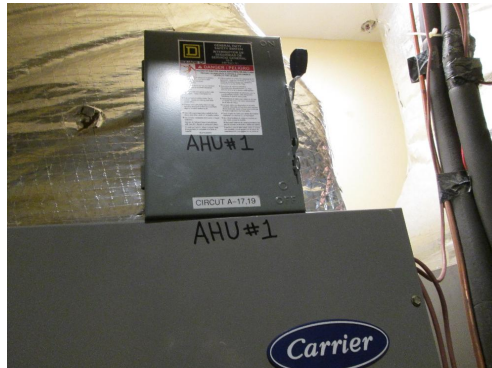
## HVAC Unit 1 - 2022

5 Tons	@ \$1,200.00
		Asset Cost	\$6,000.00
		Percent Replacement	100%
		Future Cost	\$7,600.62
	Mechanical Systems		
Placed in Service	June 2008		
Useful Life	15		
Replacement Year	22-23		
Remaining Life	8

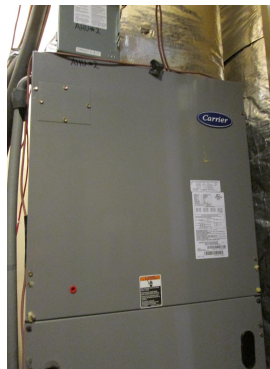
## HVAC Unit 2 - 2023

5 Tons	@ \$1,200.00
		Asset Cost	\$6,000.00
		Percent Replacement	100%
		Future Cost	\$7,828.64
	Mechanical Systems		
Placed in Service	June 2008		
Useful Life	15		
Adjustment	1		
Replacement Year	23-24		
Remaining Life	9

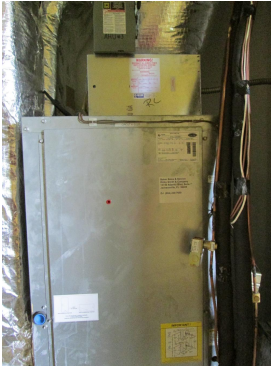
**HVAC Unit 3 - 2025**

7 Tons	@ \$1,200.00
		Asset Cost	\$8,400.00
		Percent Replacement	100%
		Future Cost	\$11,627.56
	Mechanical Systems		
Placed in Service	June 2008		
Useful Life	16		
Adjustment	2		
Replacement Year	25-26		
Remaining Life	11

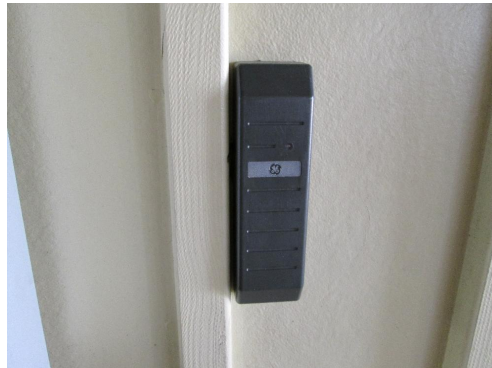
**Access Control System - 2022**

1 Lump Sum	@ \$3,500.00
		Asset Cost	\$3,500.00
		Percent Replacement	100%
		Future Cost	\$4,433.69
	Electrical Systems		
Placed in Service	June 2008		
Useful Life	15		
Replacement Year	22-23		
Remaining Life	8

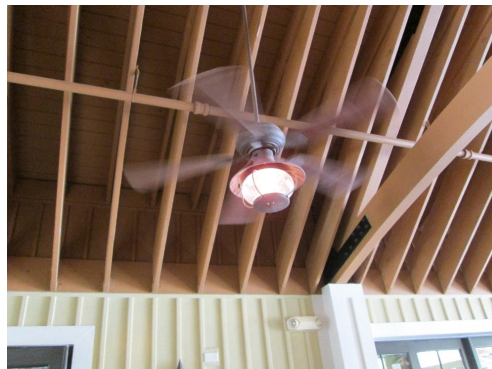
**Ceiling Fans - Exterior - 2020**

13 Each	@ \$400.00
		Asset Cost	\$5,200.00
		Percent Replacement	100%
		Future Cost	\$6,209.07
	Electrical Systems		
Placed in Service	June 2008		
Useful Life	10		
Adjustment	3		
Replacement Year	20-21		
Remaining Life	6

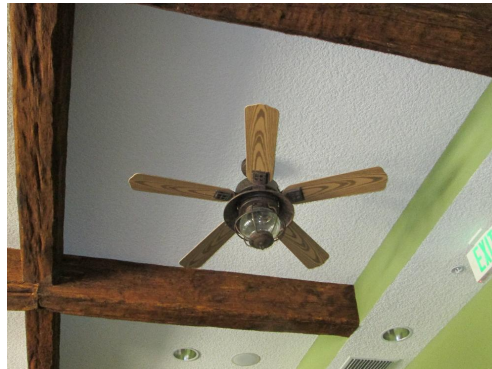
**Ceiling Fans - Family Gathering Room - 2024**

3 Each	@ \$400.00
		Asset Cost	\$1,200.00
		Percent Replacement	100%
		Future Cost	\$1,612.70
	Electrical Systems		
Placed in Service	June 2008		
Useful Life	12		
Adjustment	5		
Replacement Year	24-25		
Remaining Life	10

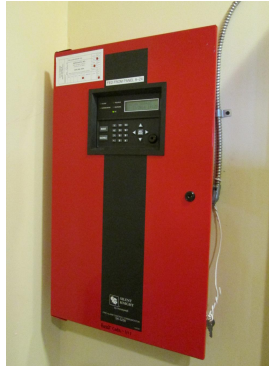
**Fire Alarm Panel Upgrades - 2027**

1 Lump Sum	@ \$1,600.00
		Asset Cost	\$1,600.00
		Percent Replacement	100%
		Future Cost	\$2,349.65
	Electrical Systems		
Placed in Service	June 2008		
Useful Life	20		
Replacement Year	27-28		
Remaining Life	13

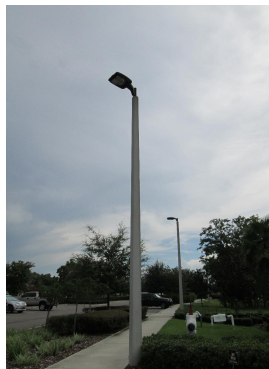
**Light Poles (Concrete) - Parking Lot - 2047**

5 Each	@ \$4,000.00
		Asset Cost	\$20,000.00
		Percent Replacement	100%
		Future Cost	\$53,046.70
	Electrical Systems		
Placed in Service	June 2008		
Useful Life	40		
Replacement Year	47-48		
Remaining Life	33

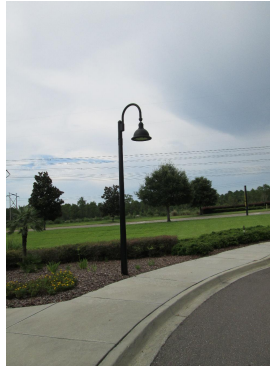
**Light Poles - Parking Lot - 2029**

6 Each	@ \$2,600.00
		Asset Cost	\$15,600.00
		Percent Replacement	100%
		Future Cost	\$24,304.29
	Electrical Systems		
Placed in Service	June 2008		
Useful Life	22		
Replacement Year	29-30		
Remaining Life	15

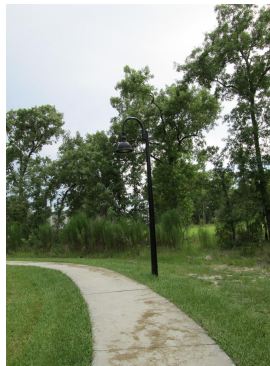
**Light Poles - Playground & Trail - 2029**

10 Each	@ \$2,600.00
		Asset Cost	\$26,000.00
		Percent Replacement	100%
		Future Cost	\$40,507.15
	Electrical Systems		
Placed in Service	June 2008		
Useful Life	22		
Replacement Year	29-30		
Remaining Life	15

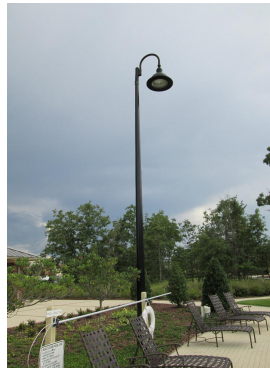
**Light Poles - Pool - 2029**

8 Each	@ \$3,600.00
		Asset Cost	\$28,800.00
		Percent Replacement	100%
		Future Cost	\$44,869.46
	Electrical Systems		
Placed in Service	June 2008		
Useful Life	22		
Replacement Year	29-30		
Remaining Life	15

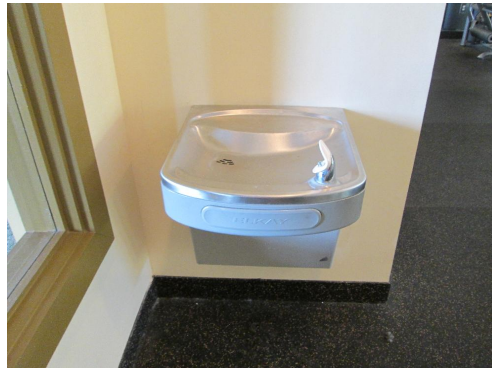
**Water Cooler - Fitness Center - 2019**

1 Each	@ \$900.00
		Asset Cost	\$900.00
		Percent Replacement	100%
		Future Cost	\$1,043.35
Plumbing Systems			
Placed in Service	June 2008		
Useful Life	12		
Replacement Year	19-20		
Remaining Life	5

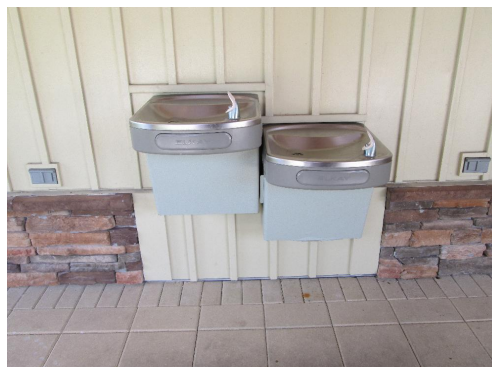
**Water Cooler - Pool - 2019**

2 Each	@ \$900.00
		Asset Cost	\$1,800.00
		Percent Replacement	100%
		Future Cost	\$2,086.69
Plumbing Systems			
Placed in Service	June 2008		
Useful Life	12		
Replacement Year	19-20		
Remaining Life	5

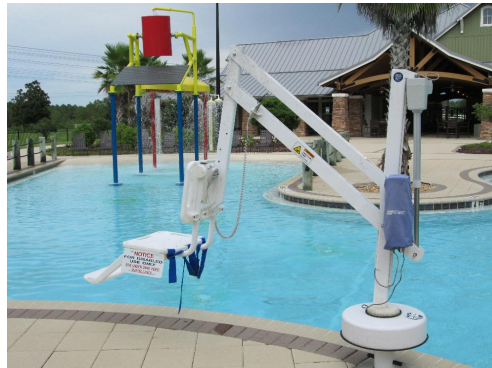
**Pool Handicap Lift - 2027**

1 Each	@ \$3,800.00
		Asset Cost	\$3,800.00
		Percent Replacement	100%
		Future Cost	\$5,580.43
Placed in Service	Swimming Pool		
Useful Life	June 2013		
Replacement Year	15		
Remaining Life	27-28		
	13

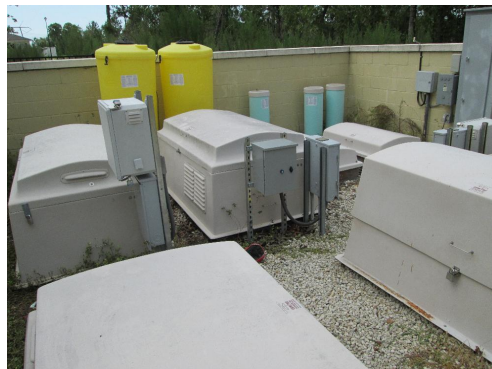
**Pool Pumps & Equipment Annual Allowance - 2014**

1 Lump Sum	@ \$3,000.00
		Asset Cost	\$3,000.00
		Percent Replacement	100%
		Future Cost	\$3,000.00
Placed in Service	Swimming Pool		
Useful Life	June 2008		
Replacement Year	1		
Remaining Life	14-15		
	0

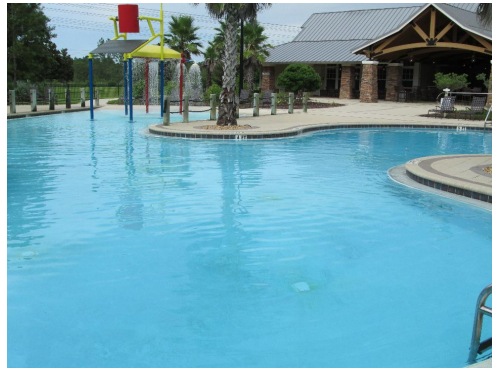
**Pool Resurfacing - 2014**

1 Lump Sum	@ \$98,000.00
		Asset Cost	\$98,000.00
		Percent Replacement	100%
		Future Cost	\$98,000.00
	Swimming Pool		
Placed in Service	June 2008		
Useful Life	12		
Adjustment	-5		
Replacement Year	14-15		
Remaining Life	0

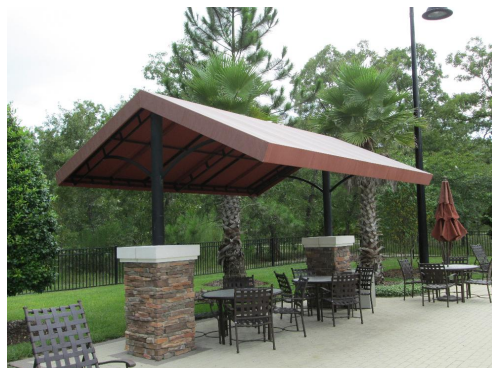
**Pool Shade Structure # 1 Fabric - 2014**

380 Square Feet	@ \$6.50
		Asset Cost	\$2,470.00
		Percent Replacement	100%
		Future Cost	\$2,470.00
	Swimming Pool		
Placed in Service	June 2008		
Useful Life	12		
Adjustment	-5		
Replacement Year	14-15		
Remaining Life	0

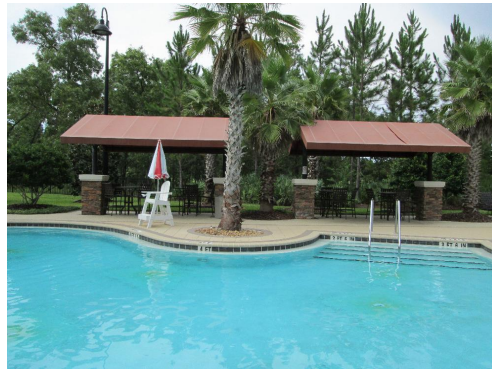
**Pool Shade Structure # 2 Fabric - 2015**

380 Square Feet	@ \$6.50
		Asset Cost	\$2,470.00
		Percent Replacement	100%
		Future Cost	\$2,544.10
	Swimming Pool		
Placed in Service	June 2008		
Useful Life	12		
Adjustment	-4		
Replacement Year	15-16		
Remaining Life	1

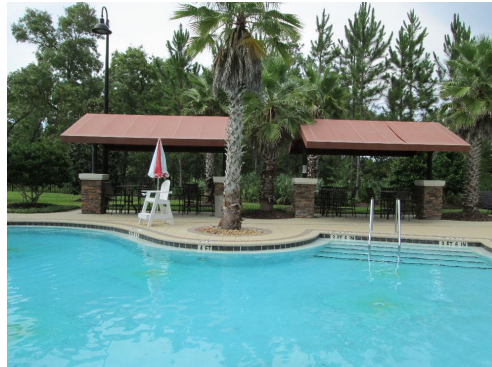
**Pool Shade Structure # 3 Fabric - 2016**

380 Square Feet	@ \$6.50
		Asset Cost	\$2,470.00
		Percent Replacement	100%
		Future Cost	\$2,620.42
	Swimming Pool		
Placed in Service	June 2008		
Useful Life	12		
Adjustment	-3		
Replacement Year	16-17		
Remaining Life	2

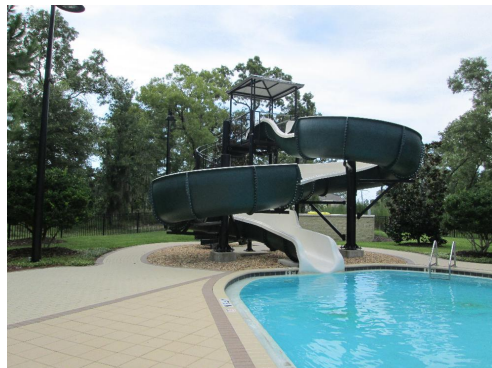
## **Pool Slide Refurbishment Allowance - 2022**

1 Lump Sum	@ \$6,000.00
		Asset Cost	\$6,000.00
		Percent Replacement	100%
		Future Cost	\$7,600.62
Placed in Service	Swimming Pool		
Useful Life	June 2008		
Replacement Year	15		
Remaining Life	22-23		
	8

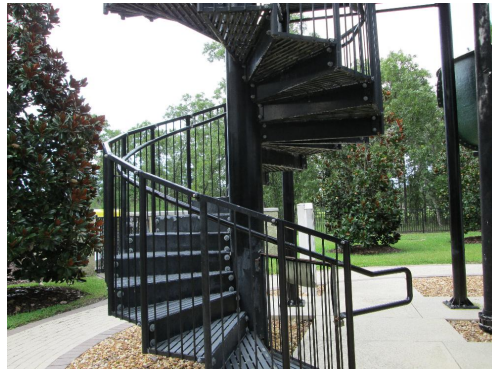
**Pool Slide Tower Stair Refurbishment - 2014**

1 Lump Sum	@ \$3,000.00
		Asset Cost	\$3,000.00
		Percent Replacement	100%
		Future Cost	\$3,000.00
	Swimming Pool		
Placed in Service	June 2008		
Useful Life	10		
Adjustment	-4		
Replacement Year	14-15		
Remaining Life	0

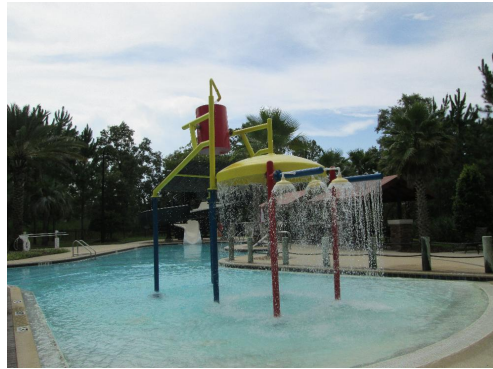
**Pool Splash Equipment Allowance - 2023**

1 Lump Sum	@ \$10,000.00
		Asset Cost	\$10,000.00
		Percent Replacement	100%
		Future Cost	\$13,047.73
	Swimming Pool		
Placed in Service	June 2008		
Useful Life	12		
Adjustment	4		
Replacement Year	23-24		
Remaining Life	9
