# Reserve Study Update Pine Ridge Plantation CDD Middleburg, Florida

Prepared for FY 2024  
Report Date: March 23, 2024

Re: Pine Ridge Plantation CDD

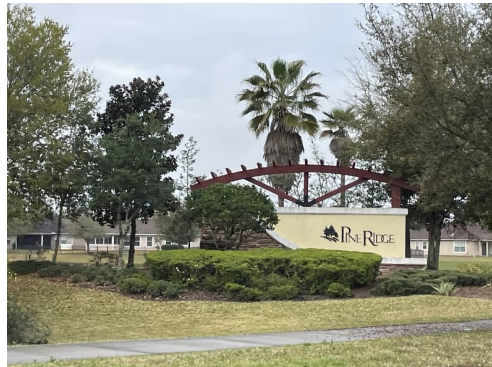
**Monument Sign (Large) Refurbishment - 2025**

Asset ID	1005	1 Lump Sum	@ \$4,000.00
		Asset Actual Cost	\$4,000.00
		Percent Replacement	100%
Category	Misc. Site Components	Future Cost	\$4,140.00
Placed in Service	June 2008		
Useful Life	15		
Adjustment	3		
Replacement Year	25-26		
Remaining Life	1

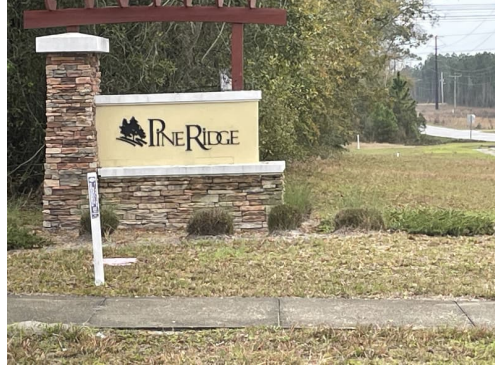
**Monument Sign (Small) Refurbishment - 2025**

Asset ID	1006	1 Lump Sum	@ \$2,000.00
		Asset Actual Cost	\$2,000.00
		Percent Replacement	100%
Category	Misc. Site Components	Future Cost	\$2,070.00
Placed in Service	June 2008		
Useful Life	15		
Adjustment	3		
Replacement Year	25-26		
Remaining Life	1

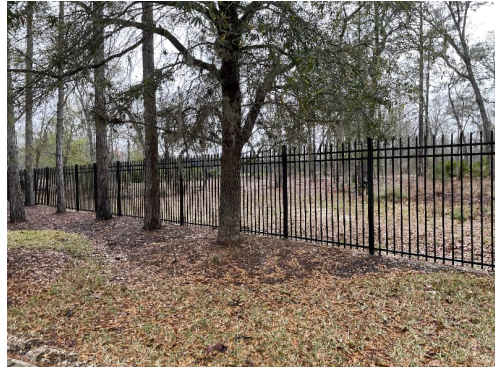
**Aluminum Fencing - Pool - 2047**

Asset ID	1047	804 Linear Feet	@ \$93.00
		Asset Actual Cost	\$74,772.00
Category	Fence & Gates	Percent Replacement	100%
Placed in Service	March 2023	Future Cost	\$164,955.59
Useful Life	25		
Replacement Year	47-48		
Remaining Life	23

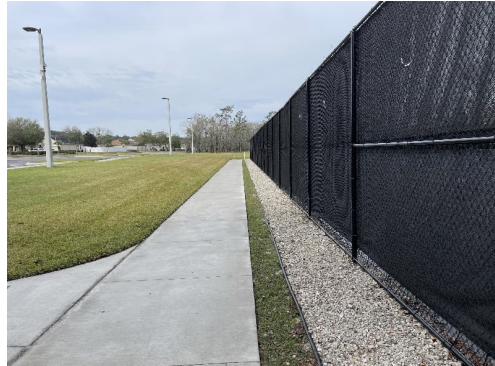
**Chain Link Fence VC - Sport Courts - 2052**

Asset ID		738 Linear Feet	@ \$96.00
		Asset Actual Cost	\$70,848.00
		Percent Replacement	100%
Category	Fence & Gates	Future Cost	\$185,633.94
Placed in Service	June 2023		
Useful Life	30		
Replacement Year	52-53		
Remaining Life	28

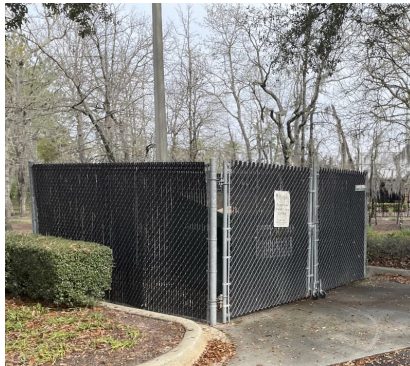
**Chain Link Fence/Gates - Dumpster - 2032**

Asset ID	1051	48 Linear Feet	@ \$48.00
		Asset Actual Cost	\$2,304.00
		Percent Replacement	100%
Category	Fence & Gates	Future Cost	\$3,033.93
Placed in Service	June 2008		
Useful Life	25		
Replacement Year	32-33		
Remaining Life	8

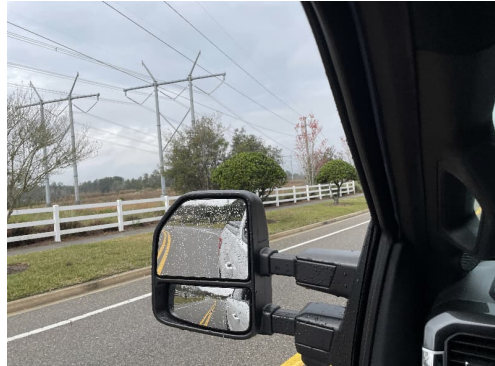
**Viny Ranch Fence - Tynes Blvd. - 2047**

Asset ID	1048	304 Linear Feet	@ \$42.00
		Asset Actual Cost	\$12,768.00
		Percent Replacement	100%
Category	Fence & Gates	Future Cost	\$28,167.67
Placed in Service	March 2023		
Useful Life	25		
Replacement Year	47-48		
Remaining Life	23

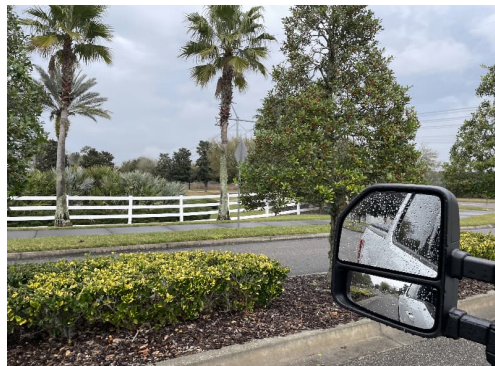
**Vinyl Fencing - Pine Ridge Pkwy - 2032**

Asset ID	1050	82 Linear Feet	@ \$32.00
		Asset Actual Cost	\$2,624.00
		Percent Replacement	100%
Category	Fence & Gates	Future Cost	\$3,455.31
Placed in Service	June 2008		
Useful Life	25		
Replacement Year	32-33		
Remaining Life	8

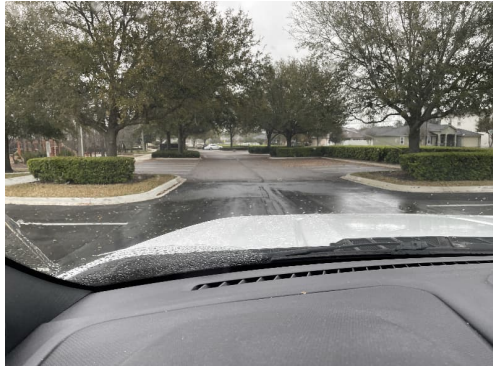
**Asphalt Resurfacing - Phase I - 2032**

Asset ID	1001	2,400 Square Yards	@ \$21.00
		Asset Actual Cost	\$50,400.00
		Percent Replacement	100%
Category	Parking Lots	Future Cost	\$66,367.18
Placed in Service	June 2008		
Useful Life	25		
Replacement Year	32-33		
Remaining Life	8

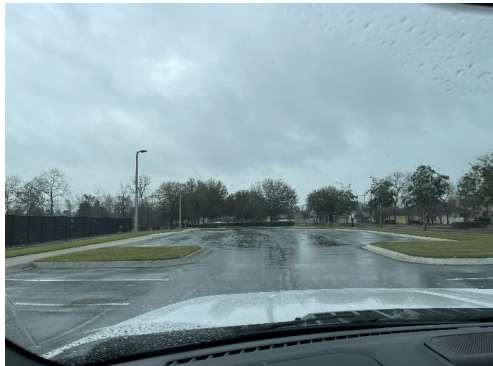
**Asphalt Resurfacing - Phase II - 2047**

Asset ID	1001	2,214 Square Yards	@ \$21.00
		Asset Actual Cost	\$46,494.00
		Percent Replacement	100%
Category	Parking Lots	Future Cost	\$102,571.09
Placed in Service	June 2023		
Useful Life	25		
Replacement Year	47-48		
Remaining Life	23

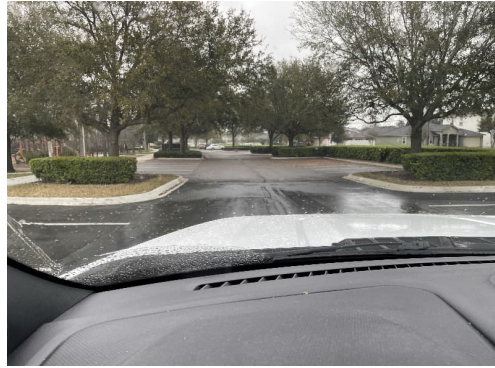
**Concrete Curbing Allow at Paving - Phase I - 2032**

Asset ID	1002	100 Linear Feet	@ \$38.00
		Asset Actual Cost	\$3,800.00
		Percent Replacement	100%
Category	Parking Lots	Future Cost	\$5,003.87
Placed in Service	June 2008		
Useful Life	25		
Replacement Year	32-33		
Remaining Life	8

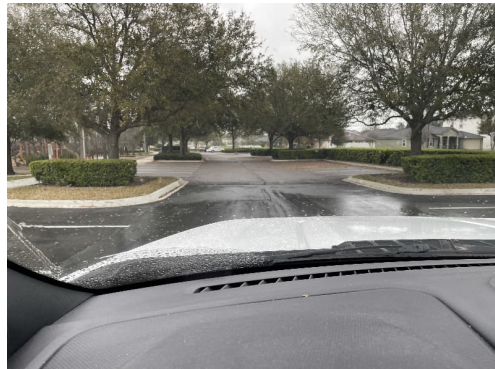
**Concrete Curbing Allow at Paving - Phase II - 2047**

Asset ID	1002	100 Linear Feet	@ \$38.00
		Asset Actual Cost	\$3,800.00
		Percent Replacement	100%
Category	Parking Lots	Future Cost	\$8,383.23
Placed in Service	June 2023		
Useful Life	25		
Replacement Year	47-48		
Remaining Life	23

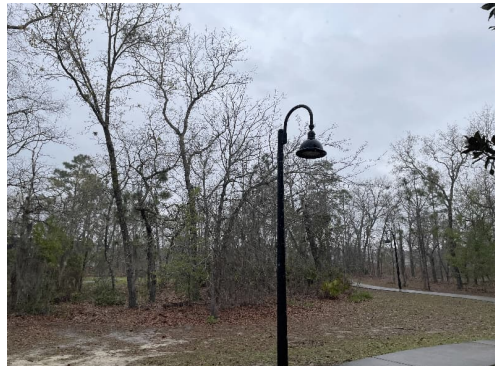
**Decorative Light Poles - Playground/Trail - 2032**

Asset ID	1062	10 Each	@ \$2,800.00
		Asset Actual Cost	\$28,000.00
		Percent Replacement	100%
Category	Site Lighting	Future Cost	\$36,870.65
Placed in Service	June 2008		
Useful Life	25		
Replacement Year	32-33		
Remaining Life	8

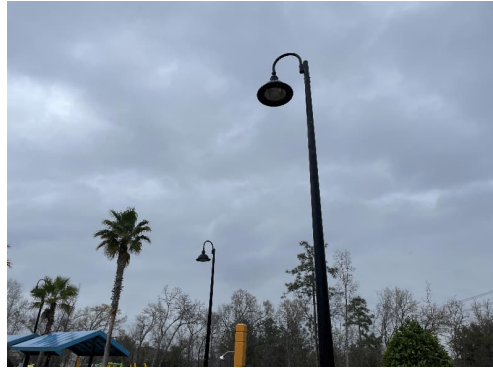
**Decorative Light Poles - Pool - 2032**

Asset ID	1069	8 Each	@ \$3,900.00
Category	Site Lighting	Asset Actual Cost	\$31,200.00
Placed in Service	June 2008	Percent Replacement	100%
Useful Life	25	Future Cost	\$41,084.44
Replacement Year	32-33		
Remaining Life	8

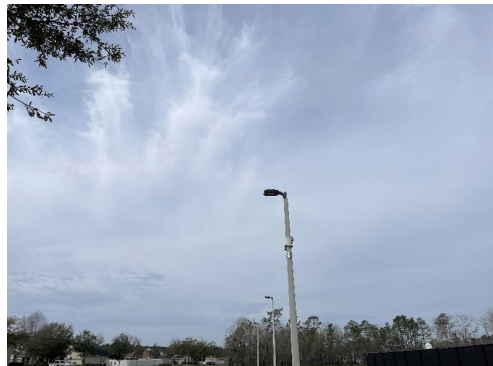
**Light Fixtures - Concrete Poles - 2042**

Asset ID	1071	8 Each	@ \$800.00
Category	Site Lighting	Asset Actual Cost	\$6,400.00
Placed in Service	June 2023	Percent Replacement	100%
Useful Life	20	Future Cost	\$11,887.93
Replacement Year	42-43		
Remaining Life	18

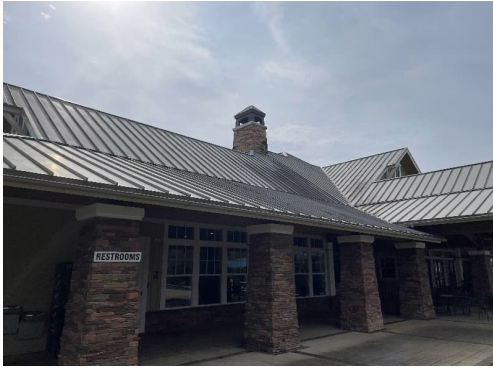
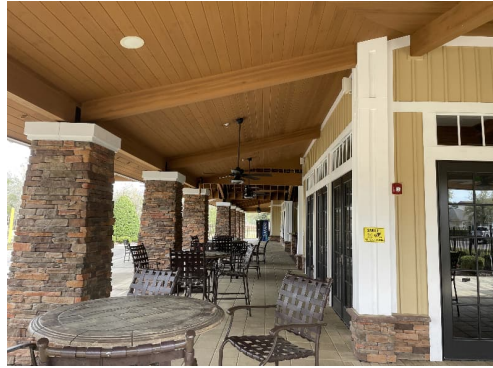
**Exterior Door/Window Allowance (Partial Replace) - 2052**

Asset ID		1 Lump Sum	@ \$40,000.00
		Asset Actual Cost	\$40,000.00
		Percent Replacement	100%
Category	Misc. Building Components	Future Cost	\$104,806.88
Placed in Service	June 2008		
Useful Life	45		
Replacement Year	52-53		
Remaining Life	28

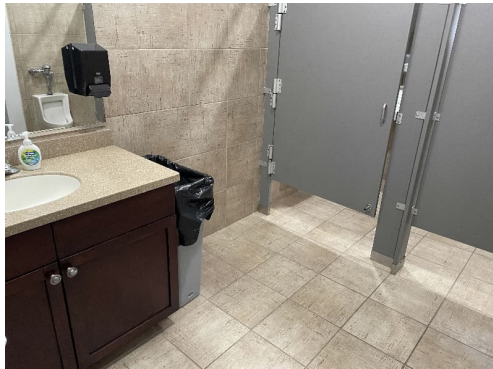
**Refurbish Allowance - Clubhouse Restrooms - 2034**

Asset ID	260 Square Feet	@ \$128.00
	Asset Actual Cost	\$33,280.00
	Percent Replacement	100%
Category: Misc. Building Components	Future Cost	\$46,944.73
Placed in Service	June 2008	
Useful Life	25	
Adjustment	2	
Replacement Year	34-35	
Remaining Life	10

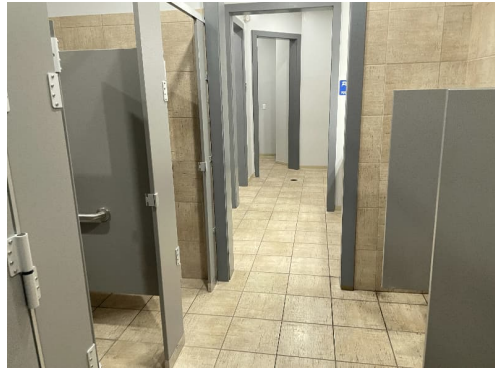
*Refurbish Allowance - Locker Rooms continued...*

Asset ID	814 Square Feet	@ \$128.00
	Asset Actual Cost	\$104,192.00
	Percent Replacement	100%
Category: Misc. Building Components	Future Cost	\$146,973.11
Placed in Service	June 2008	
Useful Life	25	
Adjustment	2	
Replacement Year	34-35	
Remaining Life	10

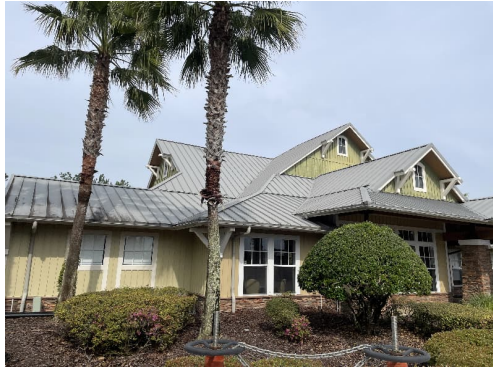
Asset ID	1073	12,200 Square Feet	@ \$14.20
Category	Roofing	Asset Actual Cost	\$173,240.00
Placed in Service	June 2008	Percent Replacement	100%
Useful Life	30	Future Cost	\$270,939.75
Replacement Year	37-38		
Remaining Life	13

Metal is discolored from previous cleaning. Recommend inspection, cleaning and repair as needed.

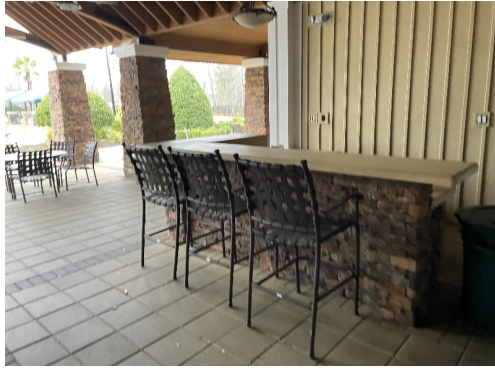
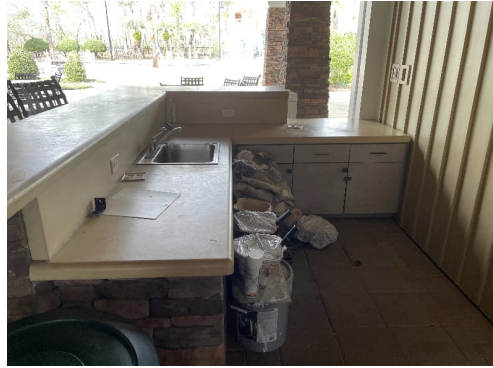
**Cabinets & Top - Outdoor Gathering - 2027**

Asset ID	1089	15 Linear Feet	@ \$220.00
Category	Cabinets & Tops	Asset Actual Cost	\$3,300.00
Placed in Service	June 2008	Percent Replacement	100%
Useful Life	20	Future Cost	\$3,658.77
Replacement Year	27-28		
Remaining Life	3

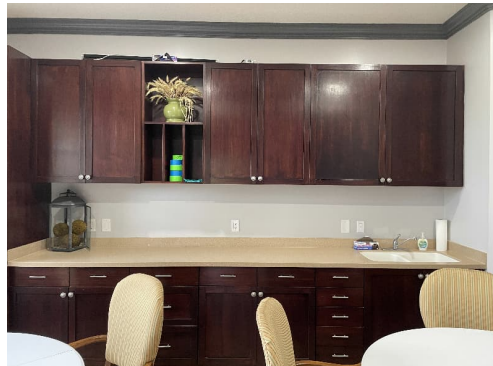
**Cabinets & Tops - Meeting Area - 2032**

Asset ID	1085	14 Linear Feet	@ \$320.00
Category	Cabinets & Tops	Asset Actual Cost	\$4,480.00
Placed in Service	June 2008	Percent Replacement	100%
Useful Life	25	Future Cost	\$5,899.30
Replacement Year	32-33		
Remaining Life	8

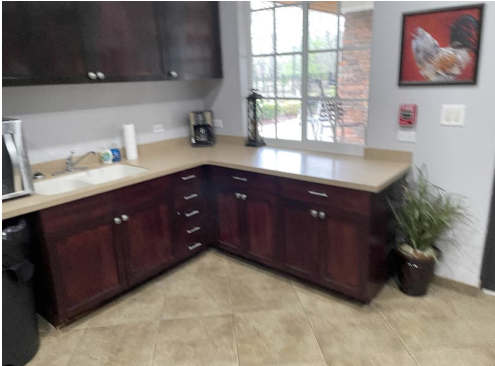
**Cabinets & Tops - Serving Room - 2032**

Asset ID	1086	29 Linear Feet	@ \$320.00
		Asset Actual Cost	\$9,280.00
		Percent Replacement	100%
Category	Cabinets & Tops	Future Cost	\$12,219.99
Placed in Service	June 2008		
Useful Life	25		
Replacement Year	32-33		
Remaining Life	8

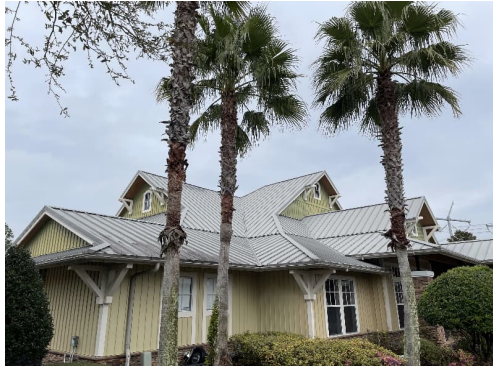
**Painting - Clubhouse Siding & Trim - 2033**

Asset ID	1075	1 Lump Sum	@ \$17,000.00
		Asset Actual Cost	\$17,000.00
		Percent Replacement	100%
Category	Exterior Painting	Future Cost	\$23,169.25
Placed in Service	March 2024		
Useful Life	10		
Replacement Year	33-34		
Remaining Life	9

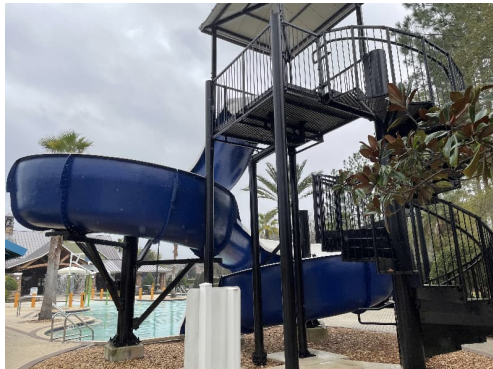
**Painting - Pool Slide Stairs - 2030**

Asset ID	1077	1 Lump Sum	@ \$3,800.00
		Asset Actual Cost	\$3,800.00
		Percent Replacement	100%
Category	Exterior Painting	Future Cost	\$4,671.17
Placed in Service	March 2023		
Useful Life	8		
Replacement Year	30-31		
Remaining Life	6

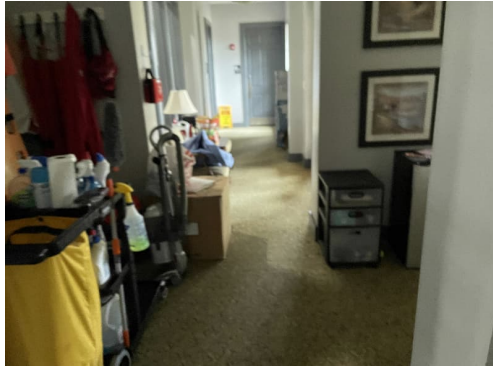
**Carpet - Clubhouse (replace with vinyl) - 2024**

Asset ID	1040	450 Square Feet	@ \$8.40
		Asset Actual Cost	\$3,780.00
		Percent Replacement	100%
Category	Flooring	Future Cost	\$3,780.00
Placed in Service	June 2008		
Useful Life	8		
Replacement Year	24-25		
Remaining Life	0

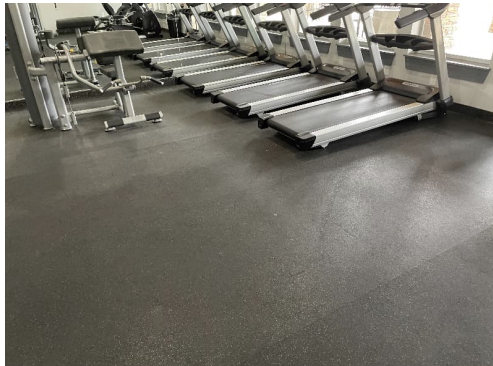
**Rubber Floor - Fitness Room - 2032**

Asset ID	1041	76 Square Yards	@ \$58.00
		Asset Actual Cost	\$4,408.00
		Percent Replacement	100%
Category	Flooring	Future Cost	\$5,804.49
Placed in Service	June 2008		
Useful Life	25		
Replacement Year	32-33		
Remaining Life	8

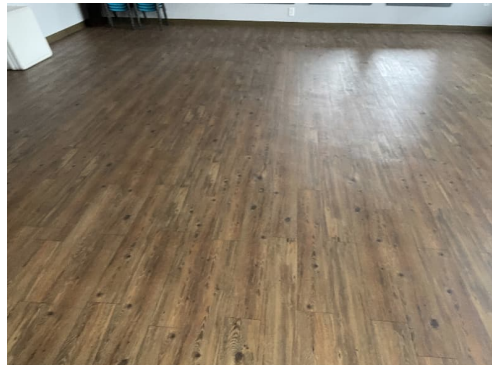
**Vinyl Plank Floor - Activity Room/Corridor - 2032**

685 Square Feet	@ \$8.40
Asset ID	1043	Asset Actual Cost	\$5,754.00
		Percent Replacement	100%
Category	Flooring	Future Cost	\$7,576.92
Placed in Service	June 2008		
Useful Life	25		
Replacement Year	32-33		
Remaining Life	8

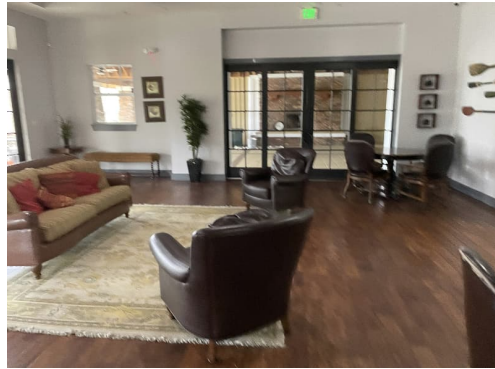
*Wood Floor - Family Gathering Room continued...*

840 Square Feet	@ \$12.00
Asset ID	1044	Asset Actual Cost	\$10,080.00
		Percent Replacement	100%
Category	Flooring	Future Cost	\$18,723.49
Placed in Service	June 2008		
Useful Life	35		
Replacement Year	42-43		
Remaining Life	18

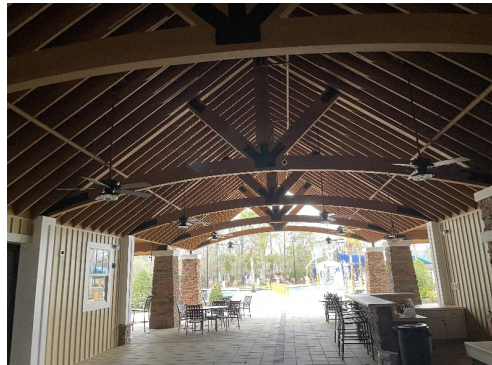
**Ceiling Fans - Exterior - 2036**

Asset ID	1064	13 Each	@ \$480.00
		Asset Actual Cost	\$6,240.00
		Percent Replacement	100%
Category	Fixtures & Equipment	Future Cost	\$9,429.07
Placed in Service	June 2022		
Useful Life	15		
Replacement Year	36-37		
Remaining Life	12

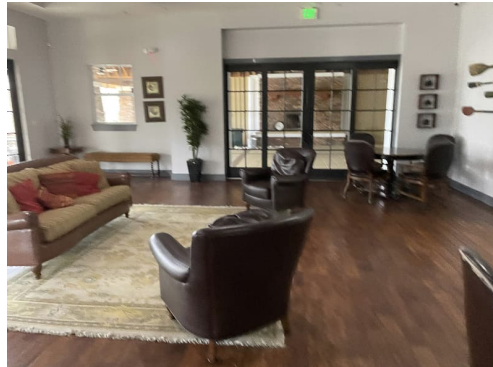
*Ceiling Fans - Family Gathering Room continued...*

Asset ID	1067	3 Each	@ \$480.00
		Asset Actual Cost	\$1,440.00
		Percent Replacement	100%
Category	Fixtures & Equipment	Future Cost	\$2,584.33
Placed in Service	June 2022		
Useful Life	20		
Replacement Year	41-42		
Remaining Life	17

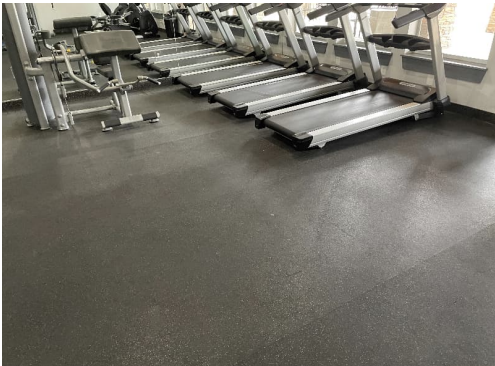
**Fitness Equip. Replace Allowance - 2047**

Asset ID	1029	1 Lump Sum	@ \$40,000.00
		Asset Actual Cost	\$40,000.00
		Percent Replacement	100%
Category	Fixtures & Equipment	Future Cost	\$88,244.58
Placed in Service	June 2008		
Useful Life	40		
Replacement Year	47-48		
Remaining Life	23

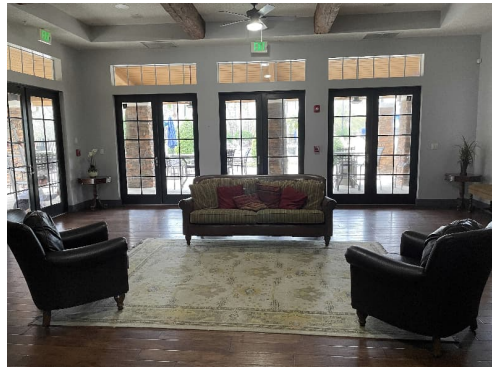
**Furniture Allowance - Clubhouse - 2029**

Asset ID		1 Lump Sum	@ \$12,000.00
		Asset Actual Cost	\$12,000.00
		Percent Replacement	100%
Category	Fixtures & Equipment	Future Cost	\$14,252.24
Placed in Service	June 2008		
Useful Life	20		
Adjustment	2		
Replacement Year	29-30		
Remaining Life	5

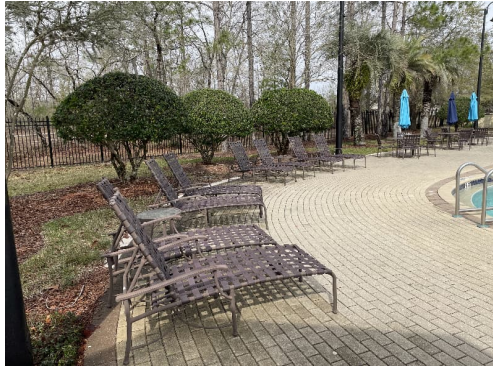
**Pool/Patio Furniture Allowance (partial replacement) - 2024**

Asset ID	1030	1 Lump Sum	@ \$3,000.00
		Asset Actual Cost	\$3,000.00
		Percent Replacement	100%
Category	Fixtures & Equipment	Future Cost	\$3,000.00
Placed in Service	June 2008		
Useful Life	1		
Replacement Year	24-25		
Remaining Life	0

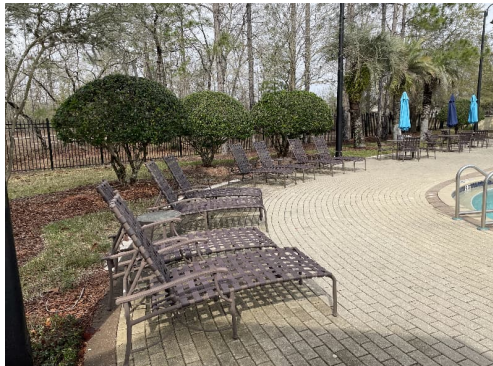
**Pool/Patio Furniture Replacement Allowance - 2032**

Asset ID	1030	1 Lump Sum	@ \$42,000.00
		Asset Actual Cost	\$42,000.00
		Percent Replacement	100%
Category	Fixtures & Equipment	Future Cost	\$55,305.98
Placed in Service	June 2008		
Useful Life	25		
Replacement Year	32-33		
Remaining Life	8

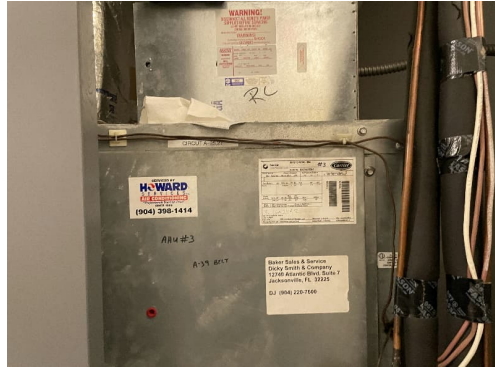
**Air Handler (refurbished) - 2039**

Asset ID	1059	1 Lump Sum	@ \$5,000.00
Category	HVAC Equipment	Asset Actual Cost	\$5,000.00
Placed in Service	November 2019	Percent Replacement	100%
Useful Life	20	Future Cost	\$8,376.74
Replacement Year	39-40		
Remaining Life	15

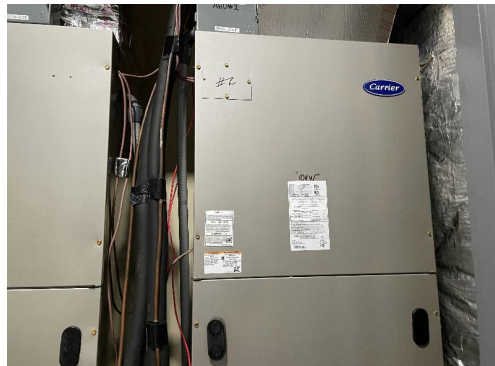
**HVAC Unit 1 - 2034**

Asset ID	1061	7 Tons	@ \$1,200.00
Category	HVAC Equipment	Asset Actual Cost	\$8,400.00
Placed in Service	July 2023	Percent Replacement	100%
Useful Life	12	Future Cost	\$11,849.03
Replacement Year	34-35		
Remaining Life	10

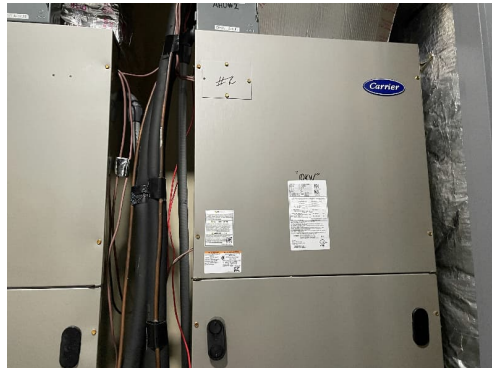
**HVAC Unit 2 - 2031**

Asset ID	1060	5 Tons	@ \$1,600.00
		Asset Actual Cost	\$8,000.00
		Percent Replacement	100%
Category	HVAC Equipment	Future Cost	\$10,178.23
Placed in Service	November 2019		
Useful Life	12		
Replacement Year	31-32		
Remaining Life	7

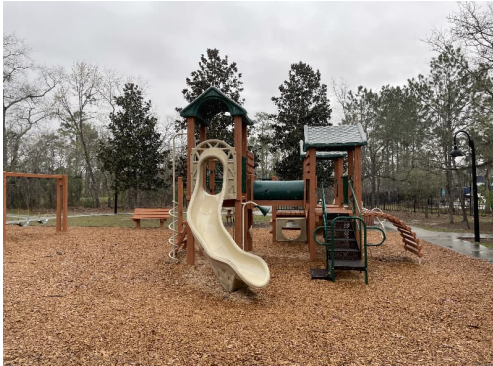
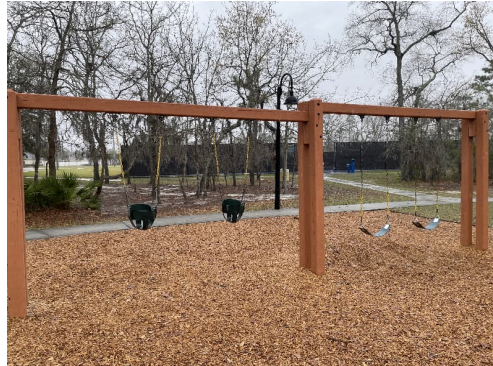
**Playground Equipment Allowance - 2027**

Asset ID	1036	1 Lump Sum	@ \$25,000.00
Category	Playground	Asset Actual Cost	\$25,000.00
Placed in Service	June 2013	Percent Replacement	100%
Useful Life	15	Future Cost	\$27,717.95
Replacement Year	27-28		
Remaining Life	3

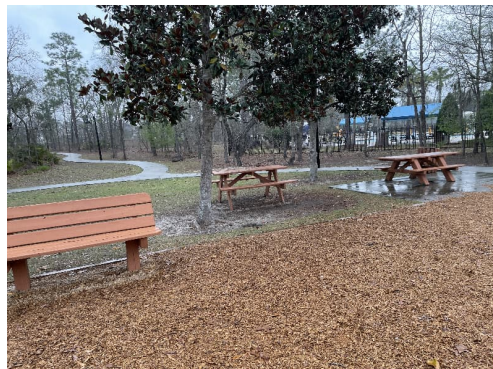
**Wood Benches/Tables - 2032**

Asset ID	1035	4 Each	@ \$1,200.00
Category	Playground	Asset Actual Cost	\$4,800.00
Placed in Service	June 2013	Percent Replacement	100%
Useful Life	20	Future Cost	\$6,320.68
Replacement Year	32-33		
Remaining Life	8

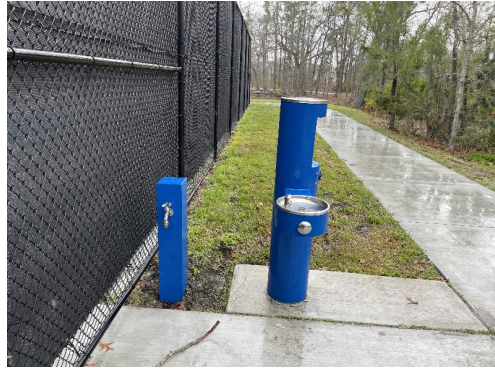
**Drinking Fountain - 2052**

Asset ID		1 Each	@ \$4,800.00
		Asset Actual Cost	\$4,800.00
		Percent Replacement	100%
Category	Sport Courts	Future Cost	\$12,576.82
Placed in Service	March 2023		
Useful Life	30		
Replacement Year	52-53		
Remaining Life	28

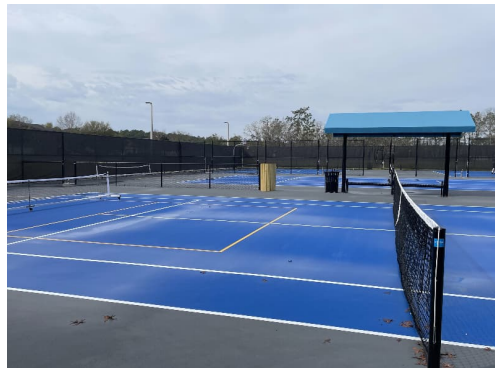
**Shade Fabric - Sport Courts - 2036**

Shade fabric scheduled for replacement in FY 2036 as a one time replacement. The next cycle

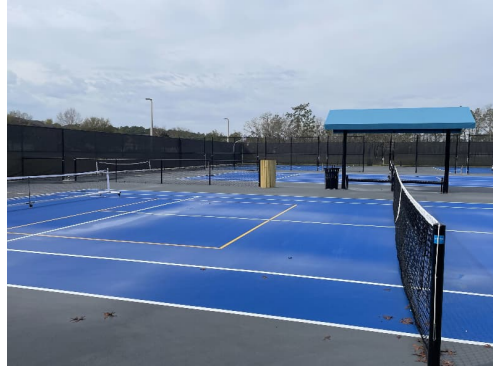
Shade structure and fabric projected replacement in FY 2048 as a one time replacement.

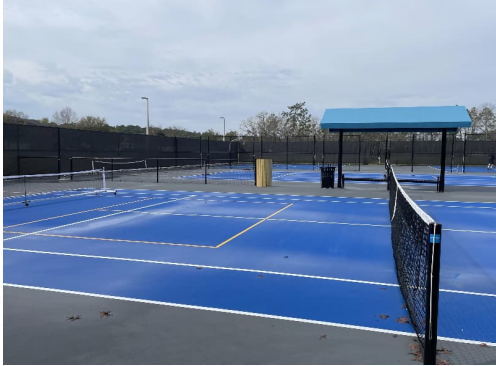
*Sport Court Replacement continued...*

Asset ID		2,520 Square Yards	@ \$76.50
		Asset Actual Cost	\$192,780.00
		Percent Replacement	100%
Category	Sport Courts	Future Cost	\$505,116.75
Placed in Service	June 2023		
Useful Life	30		
Replacement Year	52-53		
Remaining Life	28

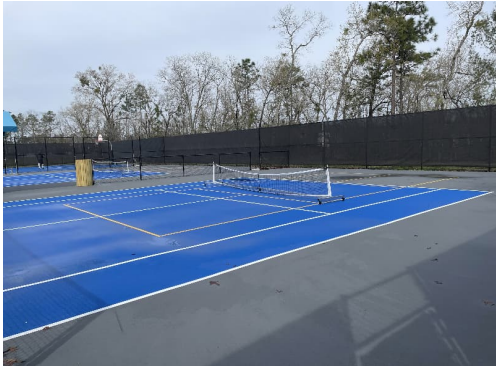
**Sport Court Resurfacing (color coat) - 2030**

Asset ID		2,520 Square Yards	@ \$9.60
		Asset Actual Cost	\$24,192.00
		Percent Replacement	100%
Category	Sport Courts	Future Cost	\$29,738.14
Placed in Service	June 2023		
Useful Life	8		
Replacement Year	30-31		
Remaining Life	6

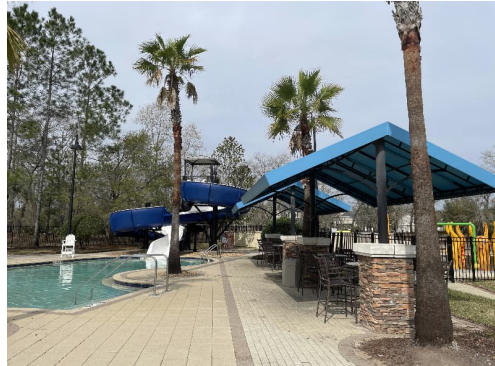
**Concrete Pavers - Pool Deck/Patio - 2047**

Asset ID		14,570 Square Feet	@ \$7.60
		Asset Actual Cost	\$110,732.00
		Percent Replacement	100%
Category	Swimming Pool	Future Cost	\$244,287.47
Placed in Service	June 2008		
Useful Life	40		
Replacement Year	47-48		
Remaining Life	23

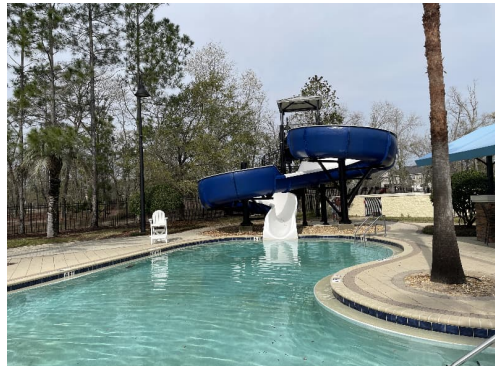
**Fiberglass Refurbish Allow - Pool Slide - 2034**

Asset ID	1020	1 Lump Sum	@ \$29,000.00
		Asset Actual Cost	\$29,000.00
		Percent Replacement	100%
Category	Swimming Pool	Future Cost	\$40,907.36
Placed in Service	June 2023		
Useful Life	12		
Replacement Year	34-35		
Remaining Life	10

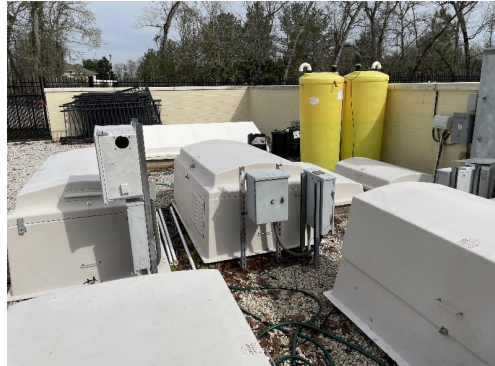
**Filtration Equip Allowance (partial replacement) - 2024**

Asset ID	1025	1 Lump Sum	@ \$3,000.00
		Asset Actual Cost	\$3,000.00
		Percent Replacement	100%
Category	Swimming Pool	Future Cost	\$3,000.00
Placed in Service	June 2008		
Useful Life	1		
Replacement Year	24-25		
Remaining Life	0

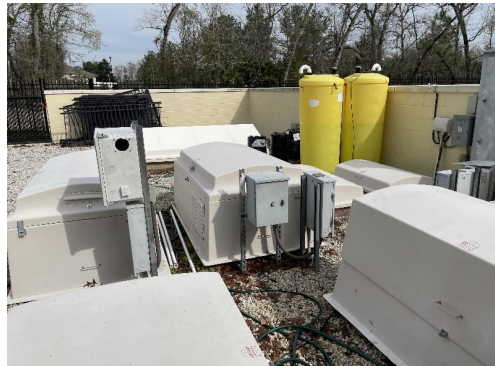
**Filtration System Refurishment Allowance - 2042**

Asset ID	1025	1 Lump Sum	@ \$30,000.00
		Asset Actual Cost	\$30,000.00
		Percent Replacement	100%
Category	Swimming Pool	Future Cost	\$55,724.67
Placed in Service	June 2008		
Useful Life	35		
Replacement Year	42-43		
Remaining Life	18

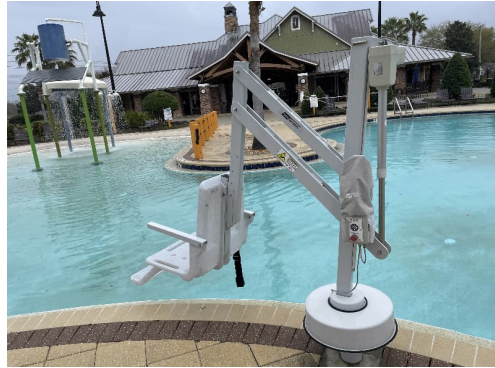
**Pool Lift - 2032**

1 Each	@ \$5,642.00
Asset ID	1021	Asset Actual Cost	\$5,642.00
		Percent Replacement	100%
Category	Swimming Pool	Future Cost	\$7,429.44
Placed in Service	June 2021		
Useful Life	12		
Replacement Year	32-33		
Remaining Life	8

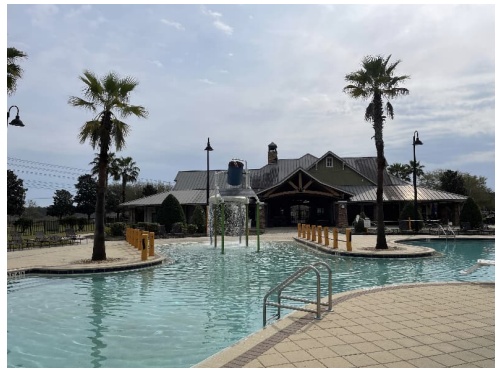
**Pool Resurfacing/Tile - 2026**

3,460 Square Feet	@ \$34.00
Asset ID	1018	Asset Actual Cost	\$117,640.00
		Percent Replacement	100%
Category	Swimming Pool	Future Cost	\$126,018.91
Placed in Service	June 2015		
Useful Life	12		
Replacement Year	26-27		
Remaining Life	2

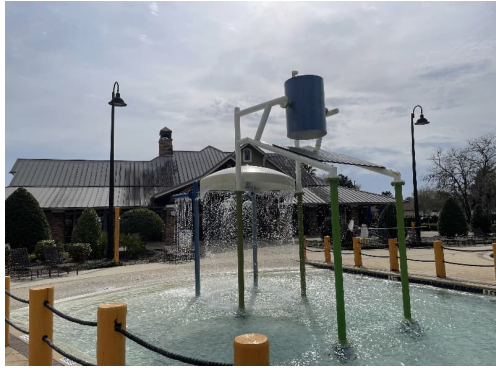
**Pool Splash Equipment Allowance - 2027**

Asset ID	1017	1 Lump Sum	@ \$20,000.00
		Asset Actual Cost	\$20,000.00
		Percent Replacement	100%
Category	Swimming Pool	Future Cost	\$22,174.36
Placed in Service	June 2008		
Useful Life	20		
Replacement Year	27-28		
Remaining Life	3

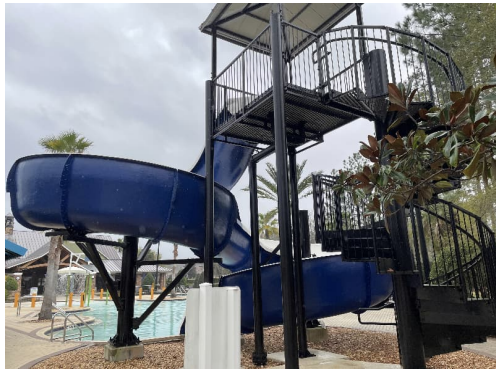
**Refurbish Allowance - Pool Slide Frame - 2034**

Asset ID	1024	1 Lump Sum	@ \$39,000.00
		Asset Actual Cost	\$39,000.00
		Percent Replacement	100%
Category	Swimming Pool	Future Cost	\$55,013.35
Placed in Service	June 2023		
Useful Life	12		
Replacement Year	34-35		
Remaining Life	10

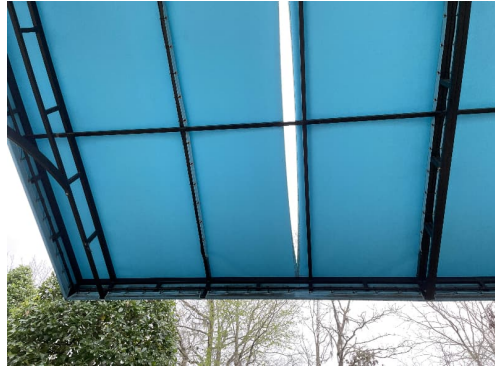
Shade fabric scheduled for replacement in FY 2024 with projected life of 14 years which occurs at time of frame and fabric replacement (seperate component). After full replacement the next replacement cycle of fabric is projected to be FY 2047.

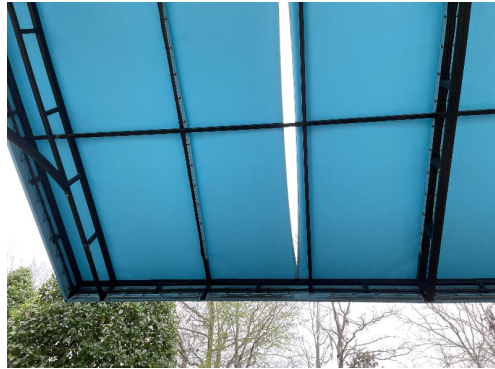
Structure and fabric replacement projected in FY 2033 as a one time replacement.

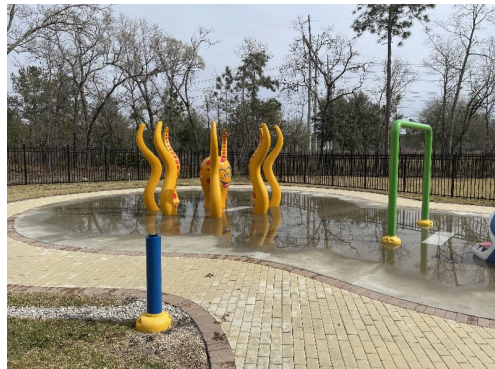
**Splash Pad Equipment Allowance - 2047**

Asset ID		1 Lump Sum	@ \$42,000.00
		Asset Actual Cost	\$42,000.00
		Percent Replacement	100%
Category	Swimming Pool	Future Cost	\$92,656.81
Placed in Service	June 2023		
Useful Life	25		
Replacement Year	47-48		
Remaining Life	23
